DUNGONG FLOOD 20-21 APRIL 2015

Post-flood damage survey

Dungog Flood, 20–21 April, 2015

GEOSCIENCE AUSTRALIA
RECORD 2015/21

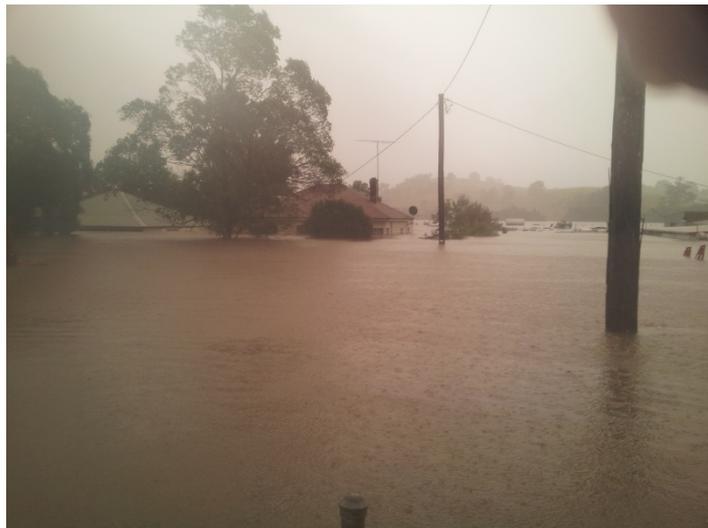
Figure 2.1 A view looking north from Hooke Street across the Myall Creek valley at close to peak flood level indicating that the entire valley is flooded. Image courtesy of Mr Tim Irwin.

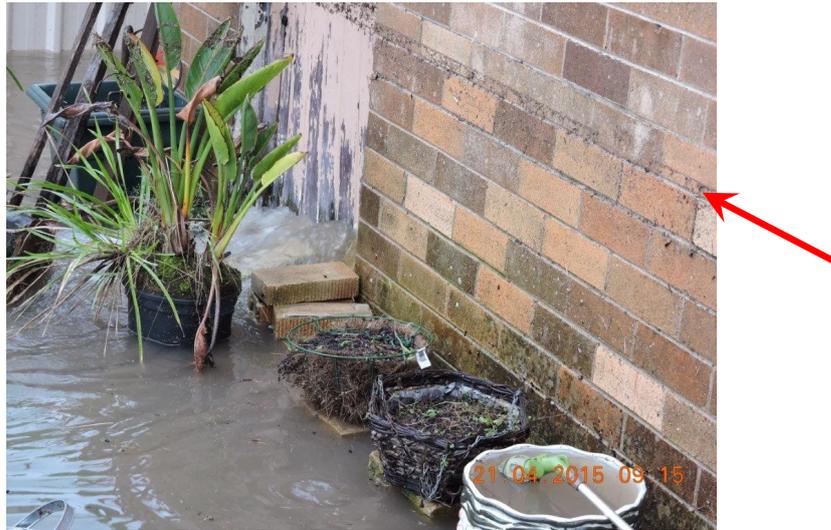
Figure 2.2 Image of flood water draining from under-floor space in a house in Hooke Street, approximately 45 minutes after peak flood (level arrowed) indicating that water levels fell faster than water could drain from the under-floor space. Image courtesy of Thompsons Mitsubishi.

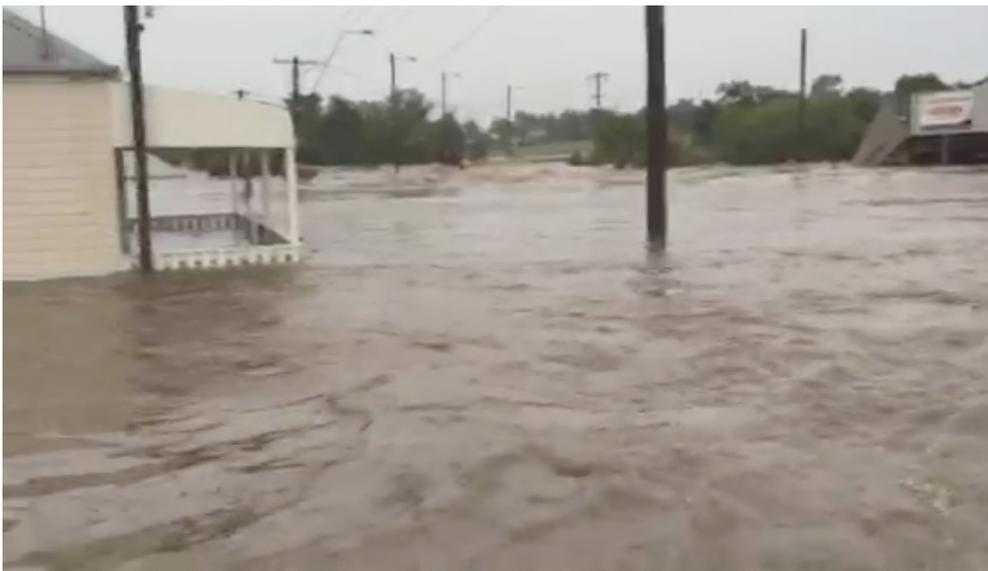
The flood waters washed away four houses at the north end of Dowling Street, close to where it crosses Myall Creek (Figure 2.3). Many other houses were inundated, some to ceiling level. Five businesses were directly impacted by flood waters.

Figure 2.3 Flood waters at northern end of Dowling Street at close to peak water level. When this image was taken four houses had been washed away. Image courtesy of Mr Neale Currie.

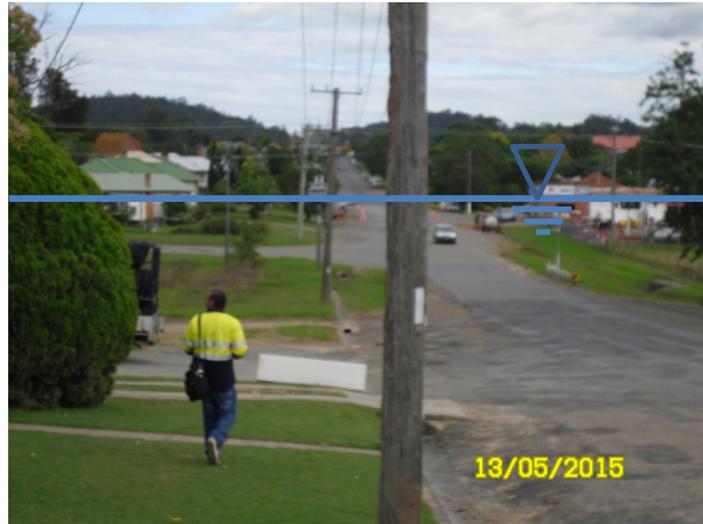
Figure 2.4 High water level in Hooke Street, Dungog, is shown by the blue line, indicating that it was flooded to a depth of several metres during the event.

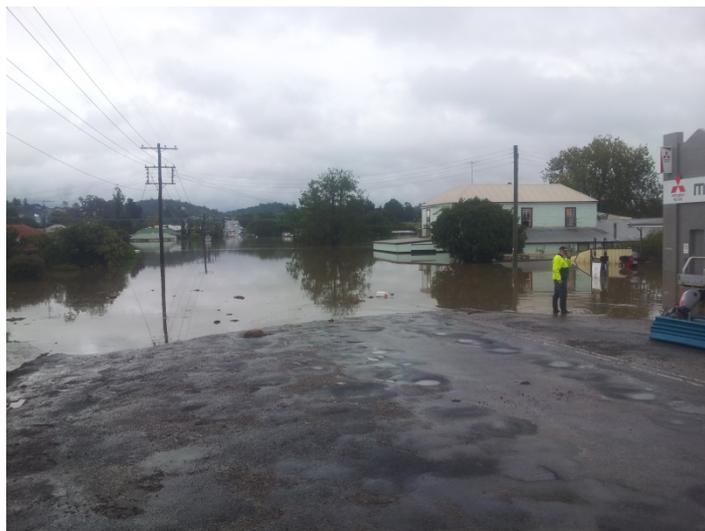
Figure 2.5 Looking west along Hooke Street with a similar aspect to Figure 2.4. The image was taken as the water level was receding, approximately 0.9m below high water level. Image courtesy of Mr Tim Irwin.

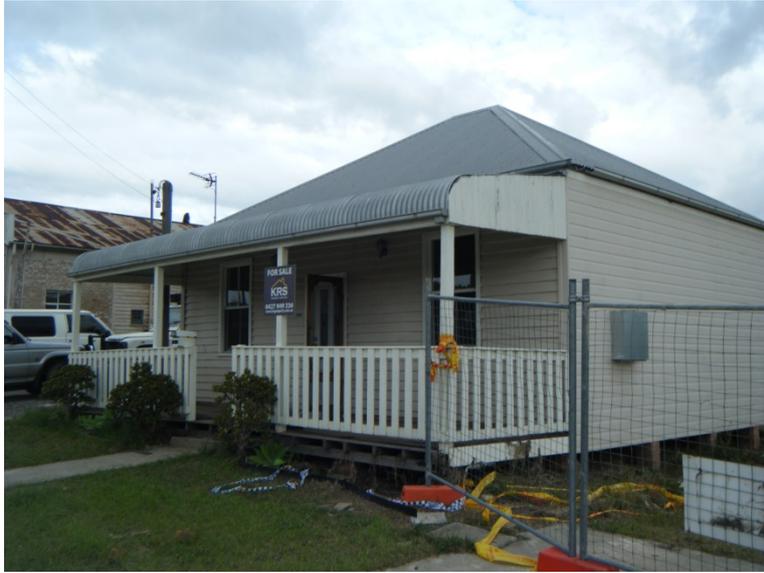
Figure 4.3 House 1, east elevation.

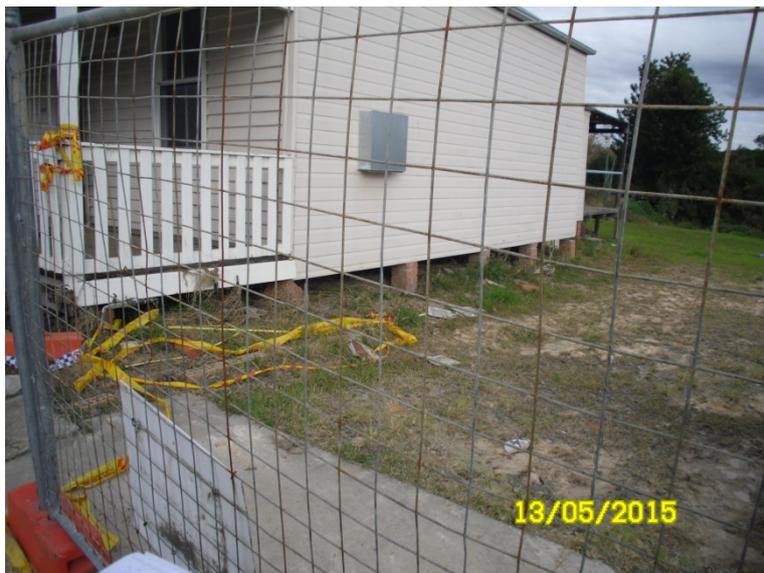
Figure 4.4 House 1, north elevation. Note ant-caps in foreground and displaced brick piers at right hand side of veranda and at rear corner of house.

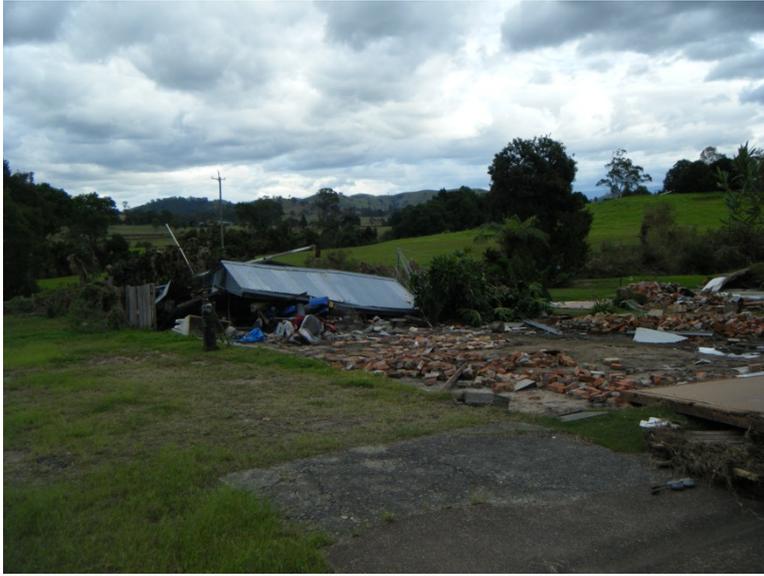
Figure 4.5 Site of House 2. Evidently a timber framed house on brick piers.

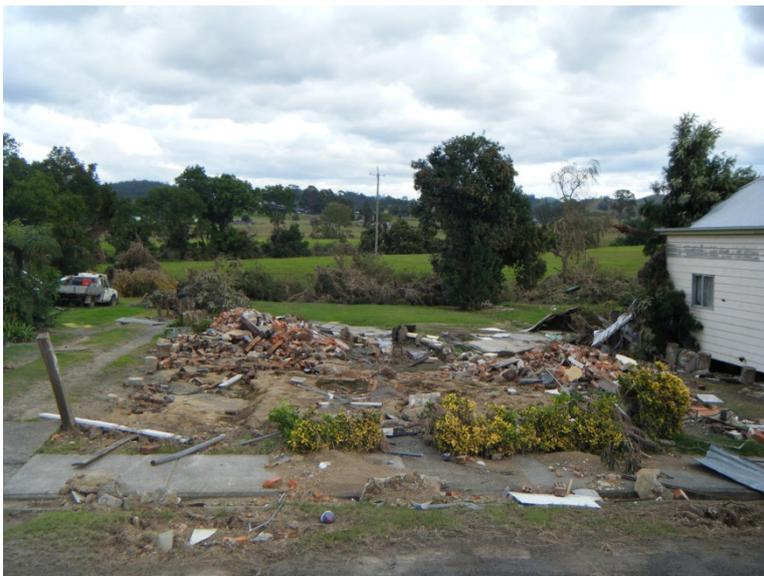
Figure 4.6 Site of House 3. Evidently a timber framed house on brick piers.

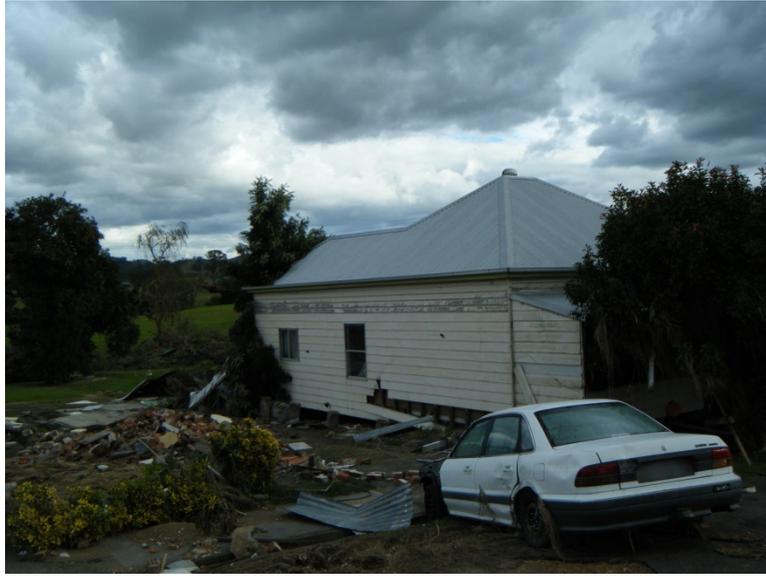
Figure 4.7 House 4. Note that house has been moved off its supporting timber stumps. The peak water level is estimated to have been 3.5m above ground level at this location (approximately gutter level on the house).

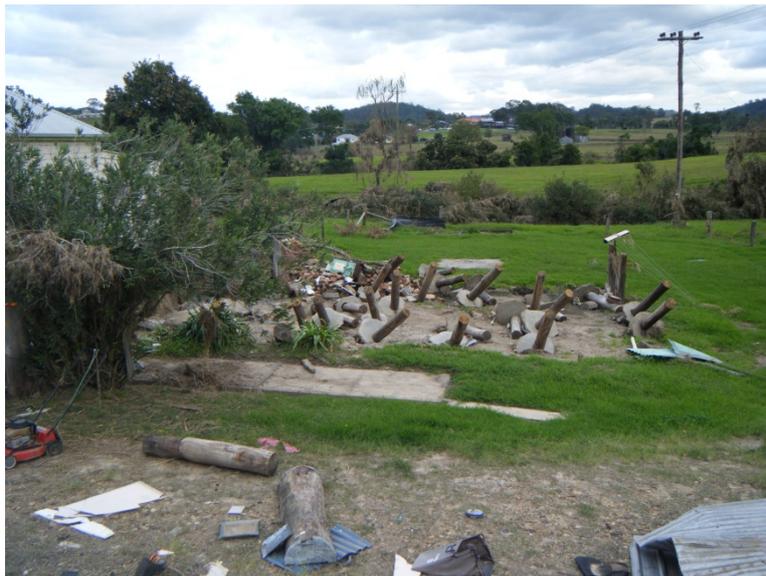
Figure 4.8 Site of House 5. Evidently a timber framed house on timber stumps. Piers are estimated to be 250mm diameter with 600 mm embedment and approximately 1.5 m projection above ground.

The only remains of House 5 were the failed timber stumps visible in Figure 4.8. An attempt was made to estimate the likely depth and velocity of water that destroyed this house. In making this estimate the failure mode of the timber stumps needs to be determined. In this case, the absence of disturbance of the soil around the stumps, such as may have resulted from a short laterally loaded pile type failure, suggested a simple overturning failure mechanism. Drag from the flowing water was calculated as per AS 5100.2-2004 (Standards Australia, 2004) and allowance made for buoyancy effects. The resulting velocity versus depth required for failure of the supporting stumps is shown in Figure 4.14.

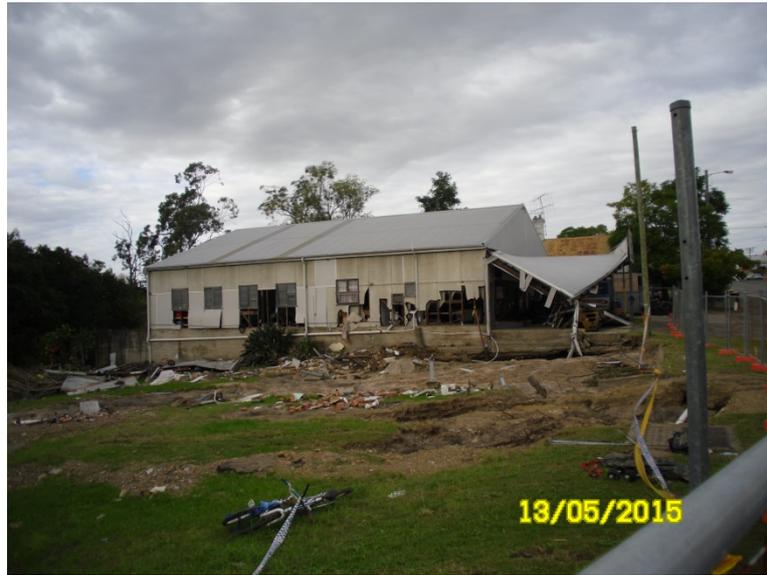
Figure 4.9 Site of House 6 with very little remaining. Evidently a timber framed house on brick piers. Note scour on downstream side of Dowling Street exposing in-ground services. Tyre business premises in background.

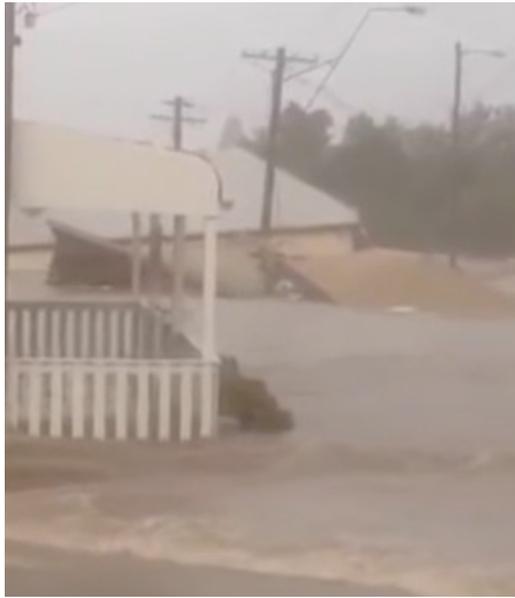
If a house has insufficient structural strength to resist the hydrodynamic forces imposed by flowing water, it may fail prior to floating such as happened to House 2 in Figure 4.13. It is difficult to determine the hazard magnitude (depth and velocity) at House 2 when it began to disintegrate. Presumably the velocity may have been about 2m/s (as derived from the stills in Figure 4.10 and Figure 4.11), however the depth is not known precisely. It is estimated at 2.2m above floor level based on the high water mark at House 4, which was approximately 2.7m above floor level, and the water level in Figure 4.13 being approximately 0.5m below maximum depth at the time it was taken.

Figure 4.13 A still from Youtube (2015) showing parts of destroyed House 2 (brown roof to right of nearest powerpole) travelling downstream. House 3 is floating and mounting the embankment up to Dowling Street (note canted attitude). The water level at House 1 in the foreground is about 0.5m below high water mark.

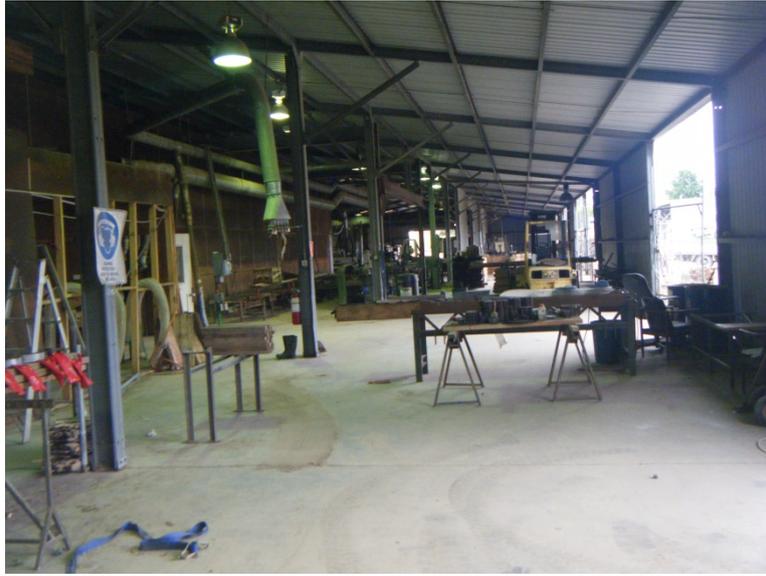
This business is located at the eastern end of Hooke Street, Dungog (Figure 4.17). The maximum water depth in the premises was measured at 1.48m above floor level. The premises are a steel portal frame building clad in sheet metal. Internally the building is divided by timber framed partitions. The structure of the building had suffered little damage, however wall cladding had been lost from the downstream elevation, girts damaged (presumably by floating debris) and internal partitions saturated. The business had lost 70% of its raw production material (swept downstream) and all machinery was rendered unusable due to inundation. The salvaged 30% of raw material required milling to smaller dimensions making it unusable for the manufacture of standard products. At the time of the field survey the business was attempting to source suitable replacement machinery. Typically it was easier for the business to buy replacement machinery than repair inundated equipment due to long and costly repair work being required to rectify elements such as motors, hydraulics and bearings. Replacement machinery was sourced either as second hand items from within Australia or new items ordered from overseas. The business reported that it would take 3 months to recommence manufacturing following the flood.

Figure 4.17 Internal view of Glulam Factory with clean-up operations in progress.

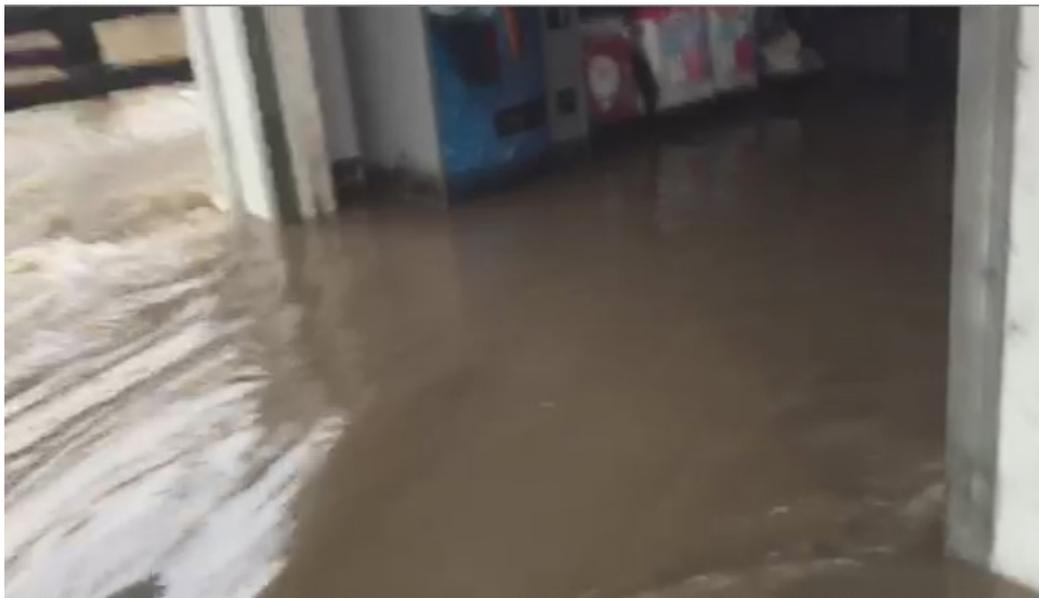
This business is located at the northern end of Dowling Street, Dungog (Figure 4.18). The maximum water depth at the street frontage was approximately 0.3m although the rear part of the premises suffered deeper inundation as the floor there is at a lower level. The building is a steel portal frame building with a mixture of masonry and timber clad walls and a metal roof. Although the building structure was undamaged apart from necessary cleaning, the business lost all stock and machinery located below the level of inundation.

Figure 4.18 Image showing flood waters at the street entrance to Motor Vehicle Repair Business 1 about 0.1m below high water. Image courtesy of Mr Neale Currie.

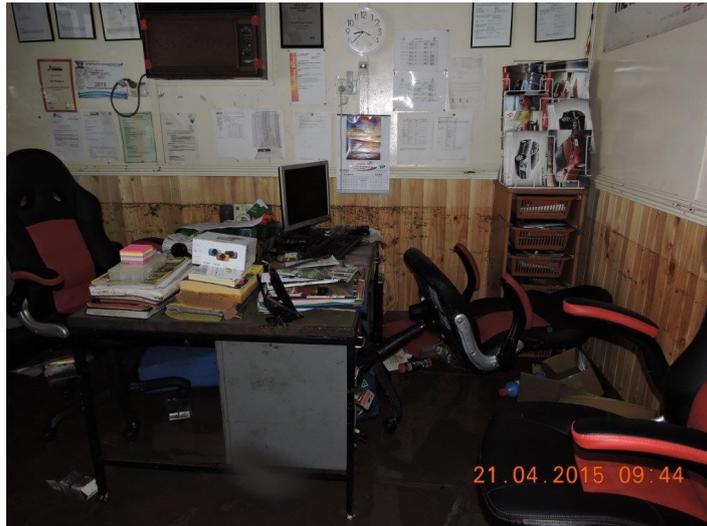
This business is located at the eastern end of Hooke Street, Dungog (Figure 4.19). The maximum water depth within the premises was approximately 1.0m. The business is housed in a brick workshop with a timber framed annex. The impact on the main building structure was minimal apart from necessary cleaning, but the timber framed annex would require re-lining after a drying out period. All stock, equipment and furnishings located below water level was lost.

Figure 4.19 Image showing the high water level in the office area of Motor Vehicle Repair Business 2. Image courtesy of Thompsons Mitsubishi.

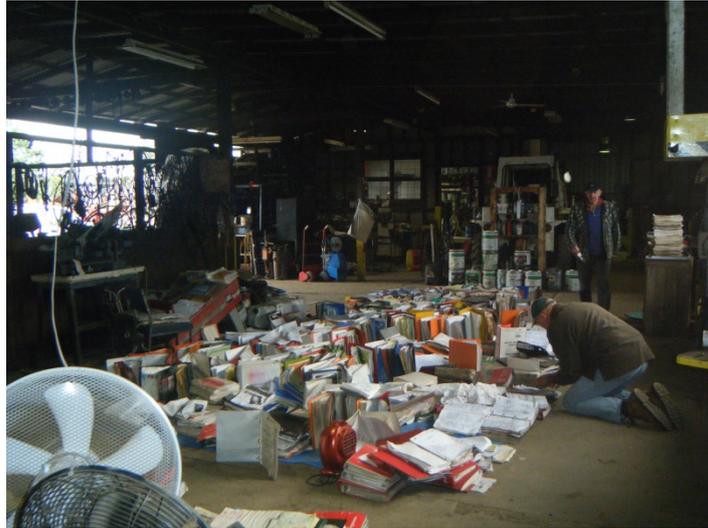
This business is located on Hooke Street, Dungog (Figure 4.20). The maximum water depth in the workshop was 3.6m above floor level, compared to a previous flood level approximately 1.0m above floor level recorded on the weekend of the 9th -10th June, 2007. The business is housed in a variety of steel framed buildings with various wall cladding materials. Other than cleaning, the structure of the buildings appeared unaffected by inundation. However, internal timber partitions require relining following drying out. Much of the stock, equipment and furnishings were lost as the water level reached almost to ceiling level.

Figure 4.20 Drying out operations in the Farm Machinery Repair business. The owner stated that one of the greater losses was irreplaceable machinery catalogues seen here whilst attempts are made to dry them.

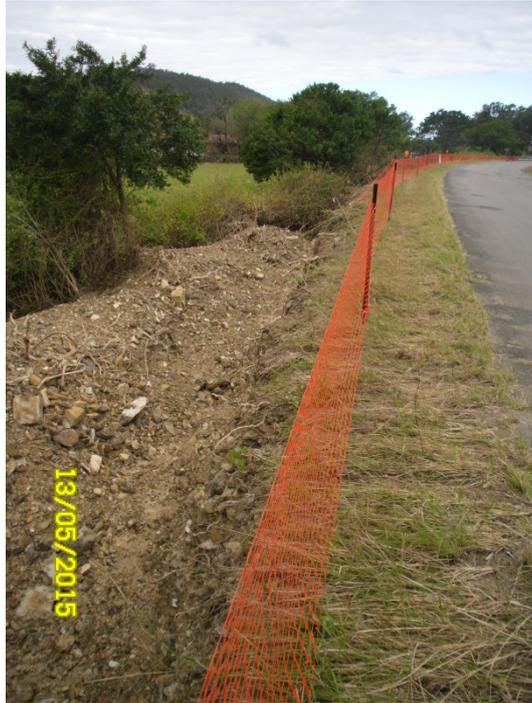
The flood water had overtopped the bridge deck as evidenced by flattened grass on the northern approach embankment and severe scouring on the downstream side of the northern embankment (Figure 4.21). Damage to the bridge consisted of:

Figure 4.21 Myall Creek bridge, northern approach embankment. Flattened grass and severe scour on downstream side of embankment indicative of over-topping. Southern end of bridge visible in top right of image.

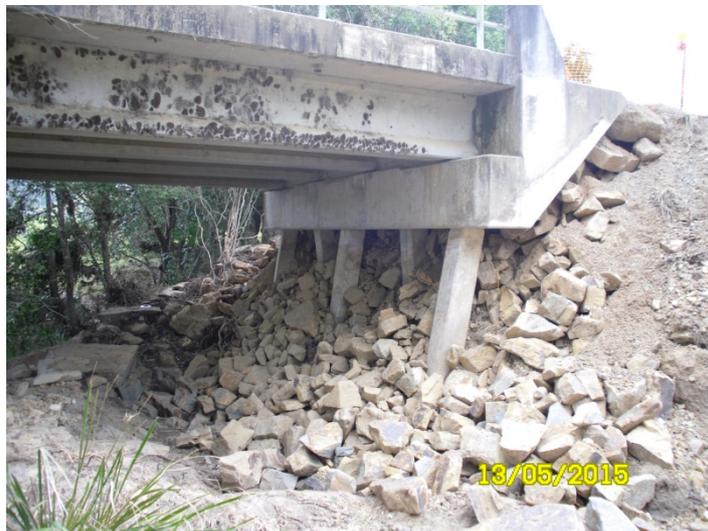
- complete erosion of scour protection and backfill at the northern abutment (Figure 4.22) resulting in a void behind the abutment,
- erosion of scour protection at the southern abutment (Figure 4.24),
- severe scouring on the downstream side of the northern approach embankment (Figure 4.21).

Figure 4.22 Myall Creek bridge. Repaired northern abutment.

At the time of survey, the northern abutment had been repaired by filling the void behind the abutment with rock and granular material. Road pavement, erosion to the northern approach embankment and removed scour protection had not yet been repaired.

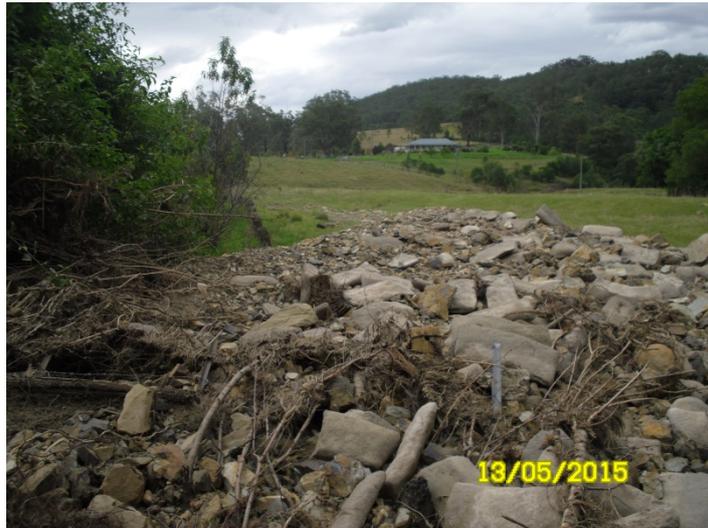
Figure 4.23 Myall Creek bridge. Eroded debris from northern abutment deposited immediately downstream. The northern approach embankment is behind shrubbery at left of image.

Eroded material had been deposited immediately downstream of the bridge (Figure 4.23 and Figure 4.25) which is suggestive of significantly increased water velocity at the constriction caused by the bridge and its approach embankments.

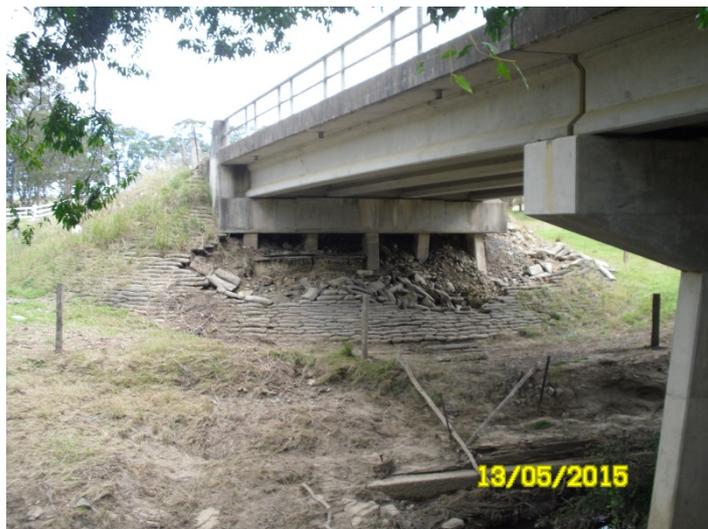
Figure 4.24 Myall Creek bridge. Scour damage to southern abutment.

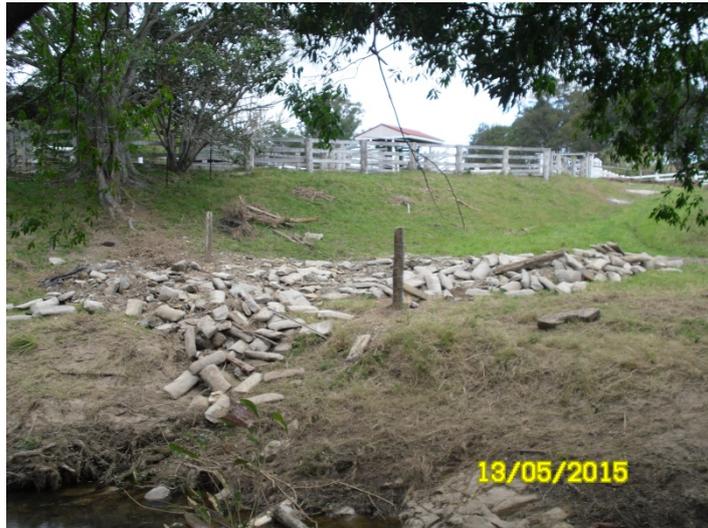
Figure 4.25 Myall Creek bridge. Eroded debris from southern abutment deposited immediately downstream of bridge.
