**SYNTHETIC DAMAGE CURVES FOR CONCRETE GIRDER  
BRIDGE DECKS UNDER FLOOD HAZARD**

**Doctor of Philosophy**

RMIT University

October 2017

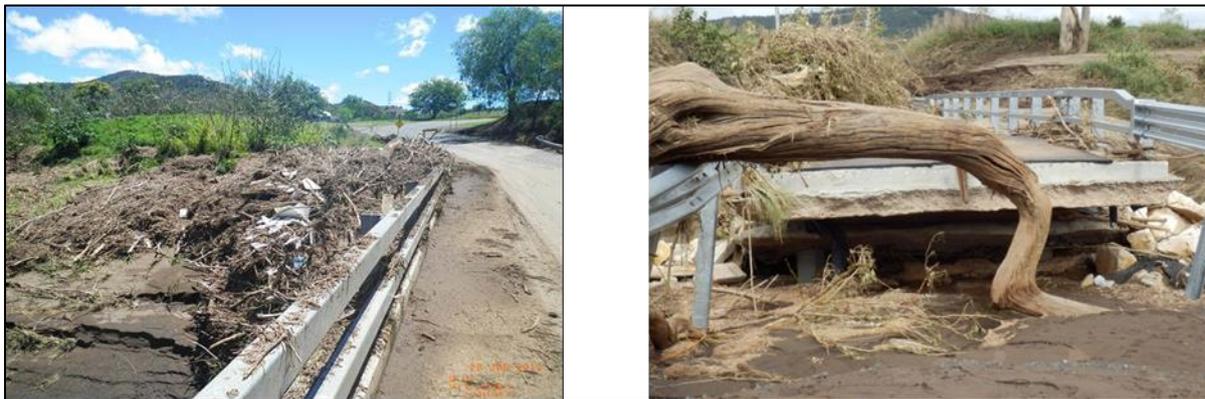
Figure 1.1: Damaged Bridges in Lockyer Valley Region in Queensland (The Lockyer Creek Flood of January 2011)

length of time it was submerged as well as the types of debris collected around or passing the bridge components. Extra care should be taken to inspect the supports of the bridges, even after the flood water recedes. Approaches of a bridge could be damaged due to debris impact, settlement or depressions. Debris against substructure and superstructure, bank erosion and damage to scour protection will damage the waterways. Bridge substructure could fail due to movement of abutments, wing walls, piers, rotation of piers and missing, damaged dislodged or poorly seating of the bearings while the superstructure could fail due to the debris on deck, rotation of deck, dipping of deck over piers or damage of girders. Pritchard (2013) identified that urban debris such as cars; containers etc. and the insufficient bridge span to through that debris were the main cause for damaging bridges during the aftermath of 2011/2012 extreme flood events in Queensland. Figure 1.1 (below) depicts some the damaged bridges from Lockyer Valley Region in Queensland.

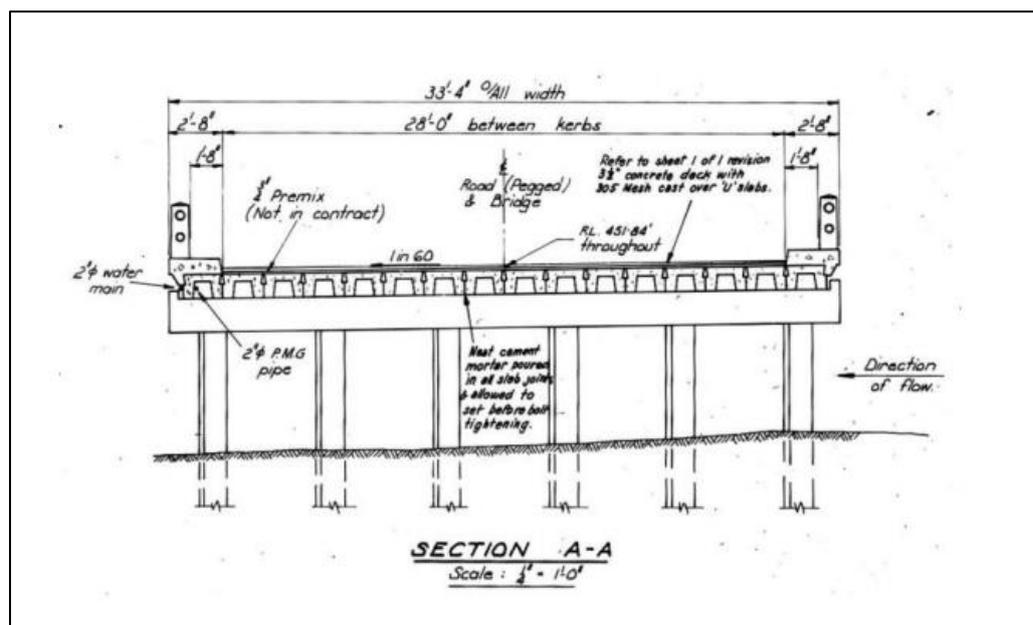
Figure 2.15: A typical U-slab bridge section constructed in Victoria (Nasim et al., 2017)

Roads Corporation of Victoria (VicRoads) has identified U-slab bridges as the old and most vulnerable structure during flood loading. This kind of bridges is under maintenance but because of its vulnerability, it is not recommended to be constructed. Figure 2.15(below) shows a typical U-slab bridge section constructed in Victoria

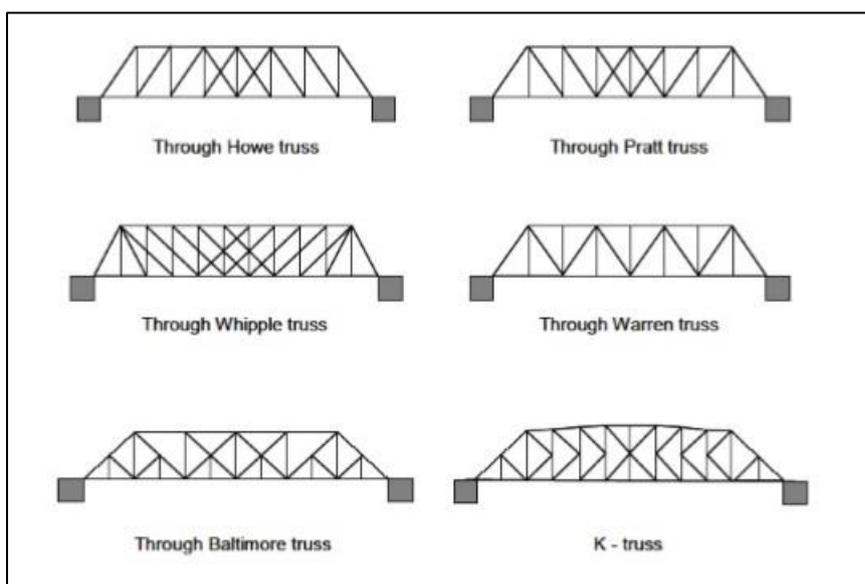
Figure 2.17: Truss Configurations. (Austroad'92, 1992)

configurations of a truss bridge are shown in Figure 2.17(below). The members steel members of a truss bridge are connected by pins. In an idealised truss the members are only subjected to axial forces, either compression or tension. A truss bridge doesn't have any member redundancy as the whole structure relies on each member performing. If a member fails then the triangulation of forces is lost (Austroad'92, 1992). Some notable steel truss bridges in Queensland are the Story Bridge in Brisbane and the Burdekin River Bridge pictured in (Figure 2.18(below)) located near Ayr. Steel truss bridges are no longer used in Queensland as there are more economical solutions available (Department of Main Roads, 2006)

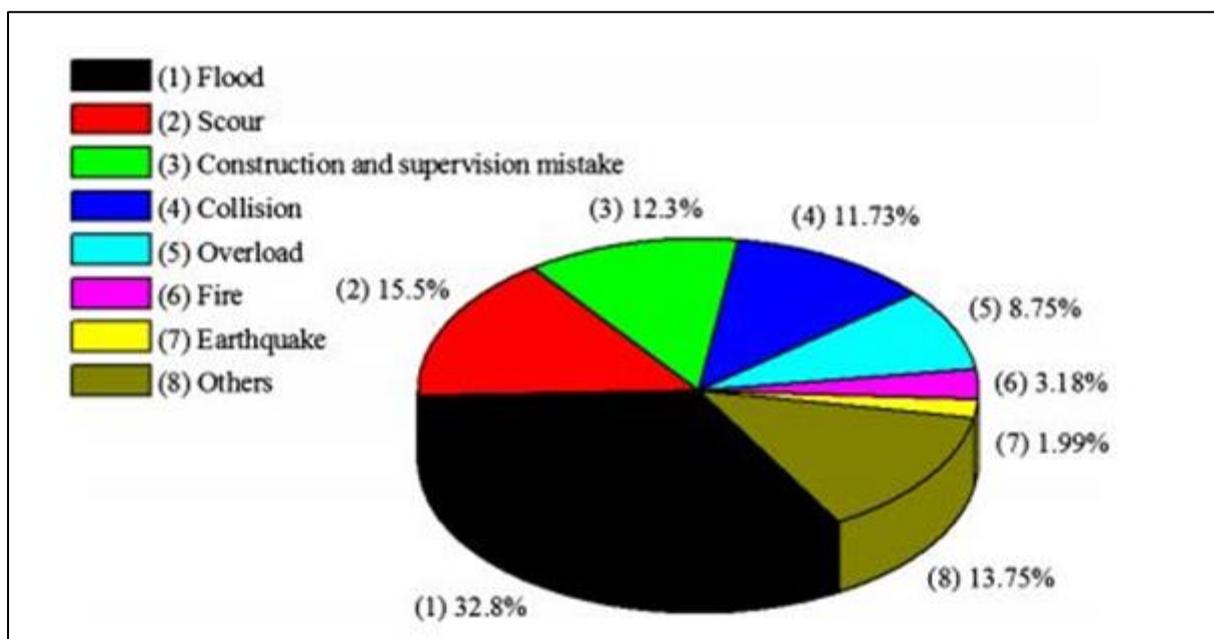
Figure 2.20: Distribution of causes of the 503 reported bridge collapses in US (Wardhana and Hadipriono, 2003)

Throughout history, bridge collapses due to various reasons are reported. This section classifies the main reasons for bridge collapse into two broad categories, namely, natural factors and human factors. Since this research assesses bridge failure under flood which is a natural hazard, only the literatures pertaining to natural factors are described in detail. According to an investigation by Wardhana and Hadipriono (2003) during the period between 1989 and 2000, a total of 503 bridge collapses were reported in the United States with the distribution of causes of these bridge collapses shown in Figure 2.20(below). From Figure 2.20, it can be observed that flood and scour together account for nearly half of the bridge collapses.

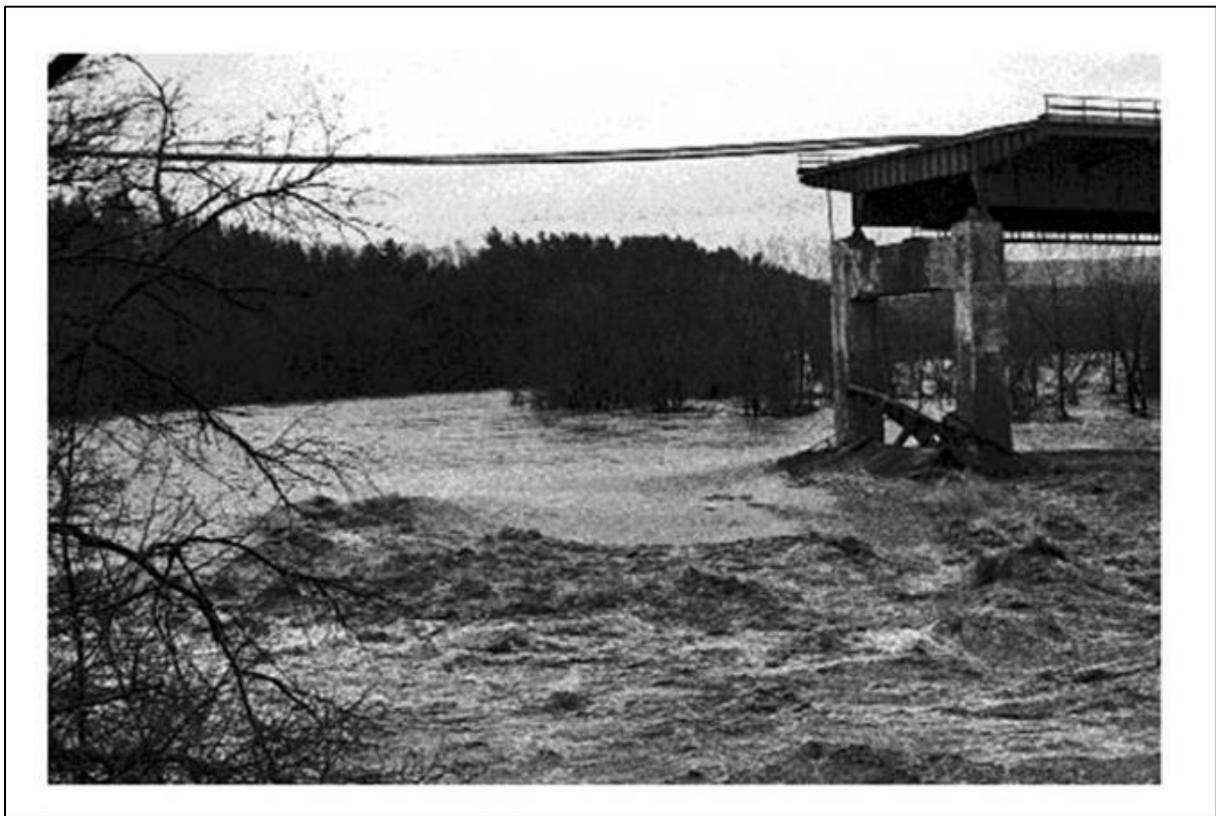
Figure 2.21: Collapse of the Schoharie Creek Bridge due to flood in 1987 (reprinted from USGS 2012)

Heavy precipitation usually leads to flooding, which may induce phenomena such as scour, erosion, river convergence, insufficient embedment depth, protection works-induced overfall or hydraulic jump, softened bedrock, sand mining, debris impact or abrasion on bridge foundations, etc. [(Witzany et al., 2008);(Hong et al., 2011);(Wang et al., 2014)]. One or a combination of these causes can result in dramatic reductions in the strength and stability of bridge key components and can even cause bridge failures, as shown in Figure 2.21(below).

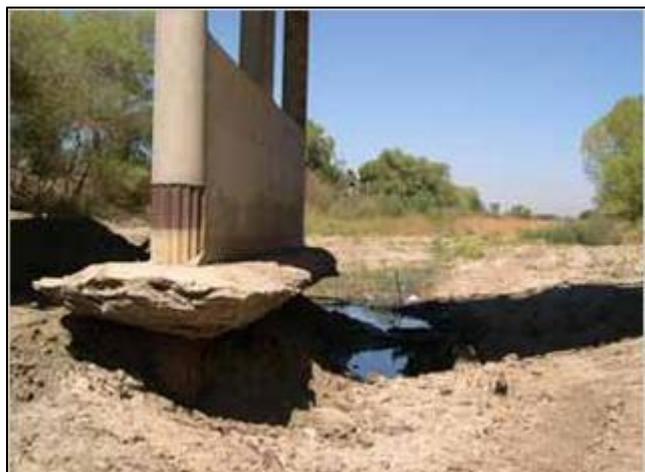
Figure 2.24: Scouring around a bridge foundation (Lin et al., 2010)

occurs in one of the following forms: pushover failure of piers, formation of structural hinges in piles, kick out failure of foundations, and excessive lateral movement of piers or foundations. Torsional failure refers to the failure of structures or structural components attacked by skewed flows. Bridge deck failure, usually in the form of deck unseating, may occur when the flood-induced external force is sufficiently large to overcome the gravity force of the bridge deck and the restraint forces from the support.

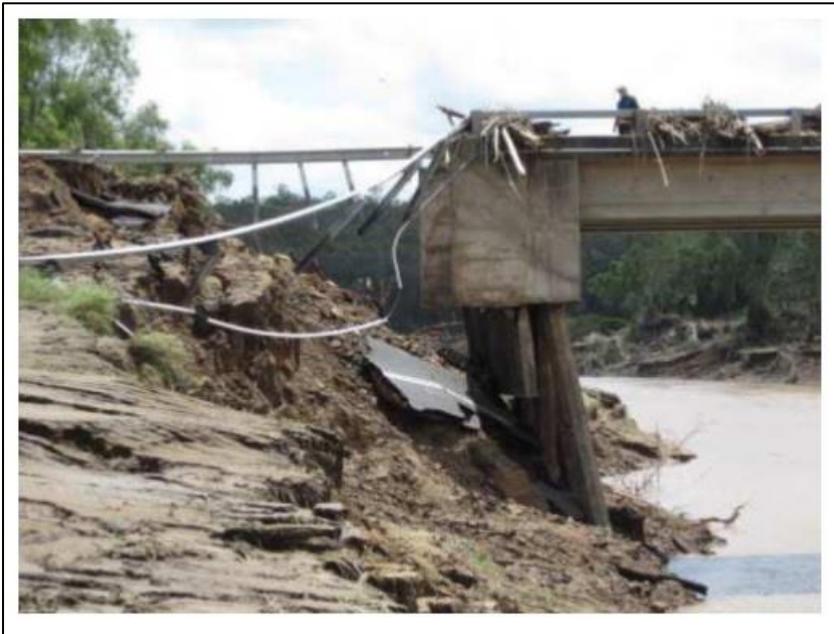
Figure 2.27: Damage to Kapernicks Bridge (Approach washed away) (Murray and Kemp, 2011)

According to Murray and Kemp (2011) this bridge was overtopped by 2 m of water and had a debris mat along the full length of the bridge to a depth of 3 m. The bridge suffered scour to the abutments and lost the approach embankment on one side, and it also had significant cracking on two girders on the superstructure due to log impact. The washed away approach is shown in Figure 2.27(below) and the cracking in the girder is shown in Figure 2.28(below).

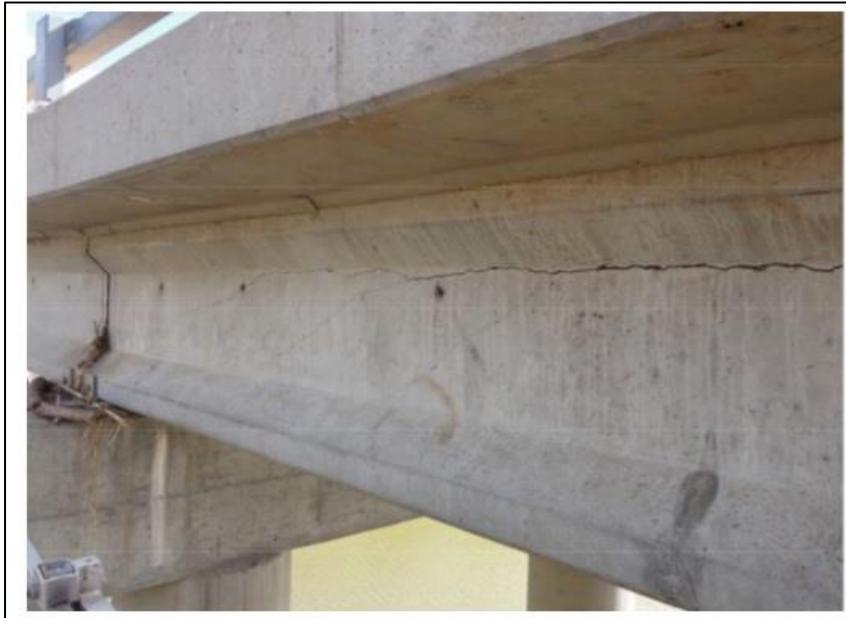
Figure 2.28: Damage to Kapernicks Bridge (Cracking in girder) (Murray and Kemp, 2011)

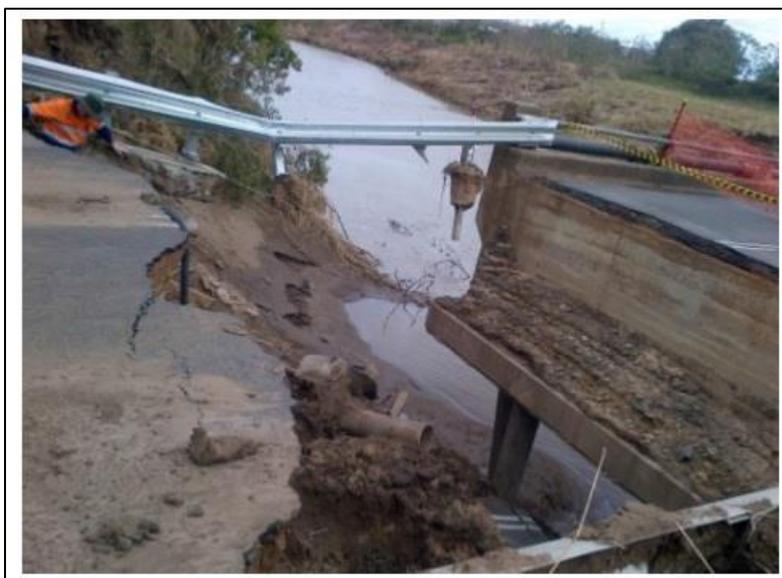
Figure 2.29: Abutment washed away on Gatton-Esk Road bridge (Ezeajugh, 2014)

Several other bridges were damaged in the Lockyer Valley in these flood events. A washed away abutment on the Gatton-Esk Road Bridge over the Lockyer Creek is shown in Figure 2.29(below). The Geoff Fisher Bridge, located near Fernvale and crosses the Brisbane River, was subjected to scour around its piers and the foundation piles were exposed as illustrated in Figure 2.30(below). Two timber bridges also required replacement after these flood events (Pritchard, 2013).

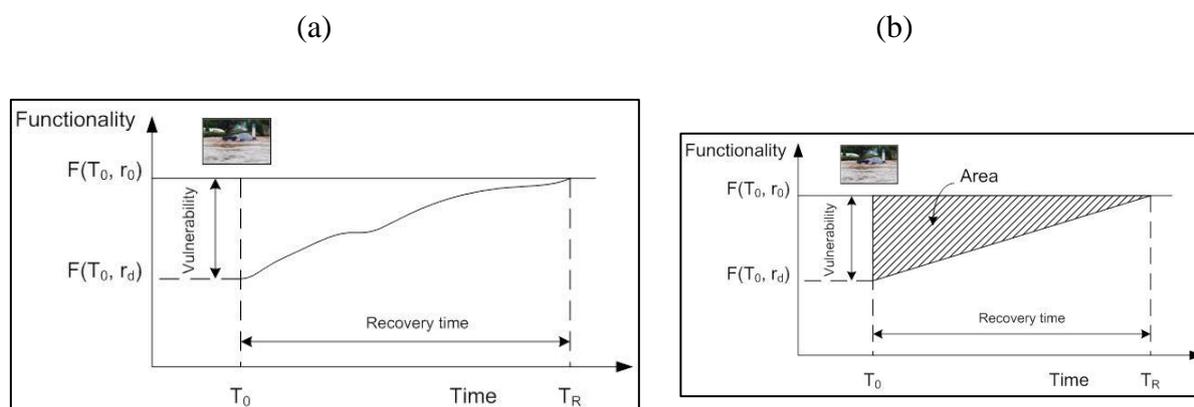
Figure 2.31: Representation of resilience and vulnerability

Figure 2.31 (a) shows the functionality of an infrastructure with time. At time  $T_0$ , the system was fully functioning [ $F(T_0, r_0)$ ] when the extreme event occurred. Functionality was reduced to  $F(T_0, r_d)$  due to the damage to the infrastructure system. At time  $T_R$ , the system completely recovered and started functioning as it was at time  $T_0$ . By considering the above qualities for a resilient system, it can be concluded that if the functionality due to damage is not much and/or if the recovery time is less, then the system is more resilient. Therefore if the area shown in Figure 2.31 (b) is less, the system is more resilient.

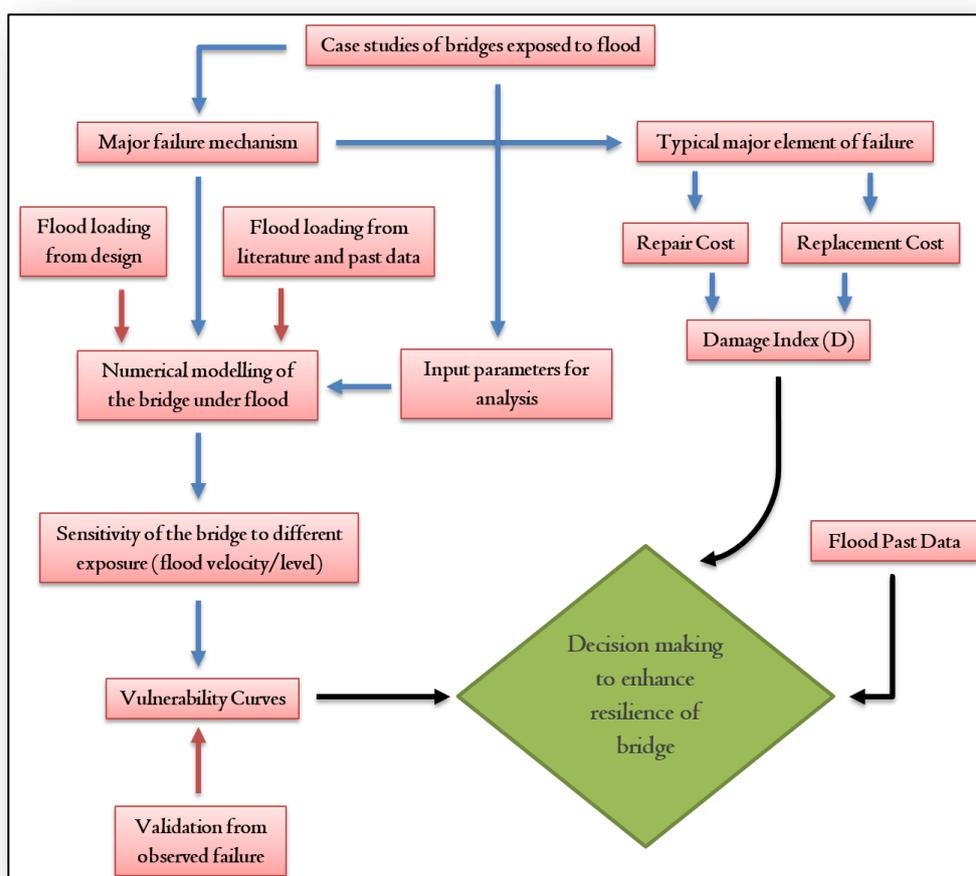
Figure 3.1: Research Methodology

The overall research methodology is illustrated through a flow chart given in Figure 3.1.

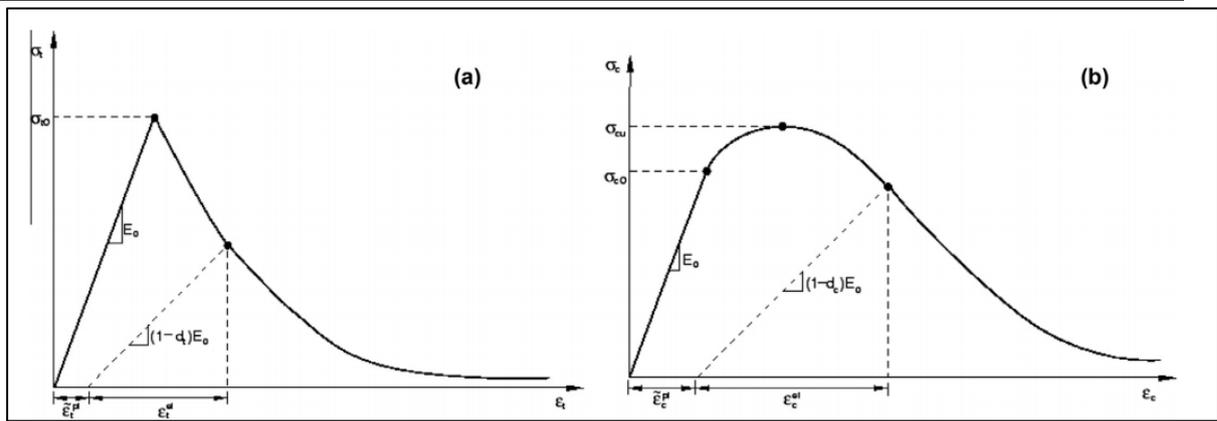
Figure 3.2: Response of concrete to uniaxial loading in tension (a) and compression (b). (Hanif et al., 2016)

Figure 3.2(below). For the CDP model, the default values of the dilation angle, eccentricity,  $f_{b0}/f_{c0}$ , K and viscosity parameter were used as 35, 0.1, 1.16, 0.667 and 0.01, respectively. The mechanical properties of concrete are summarized in Table 3-2, while the input constitutive relations and the damage parameters as a function of the compressive and tensile strengths are shown in Figure 3.3, Figure 3.4, Figure 3.5 and Figure 3.6

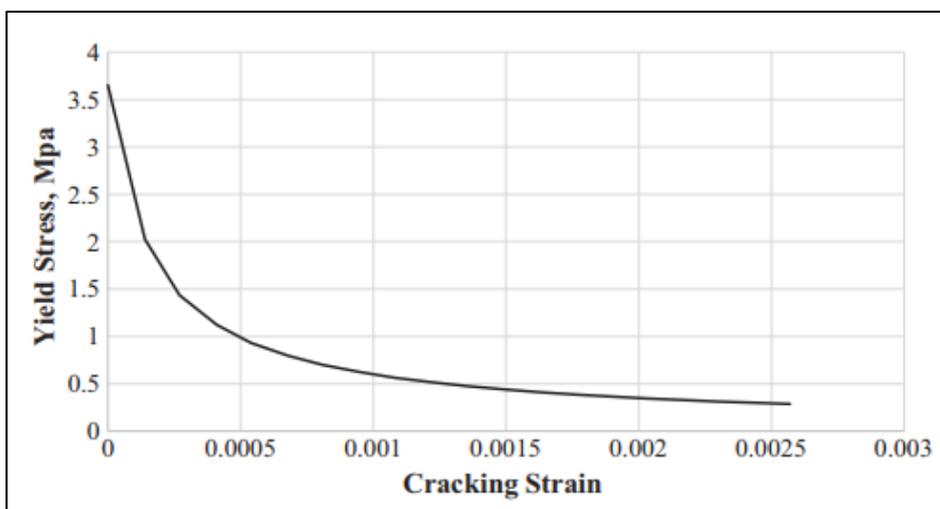
Figure 3.4: Concrete tensile softening model, yield stress vs cracking strain (Hanif et al., 2016).

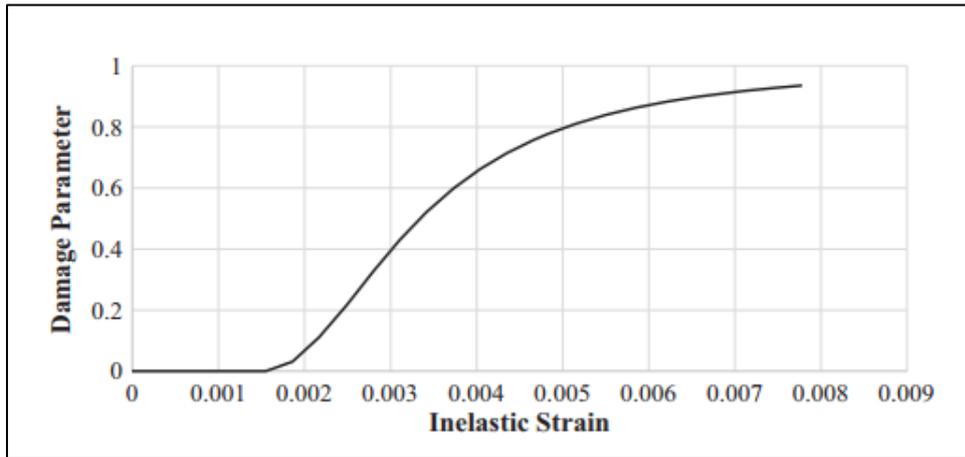
Figure 3.5: Damage parameter vs inelastic strain (Hanif et al., 2016)

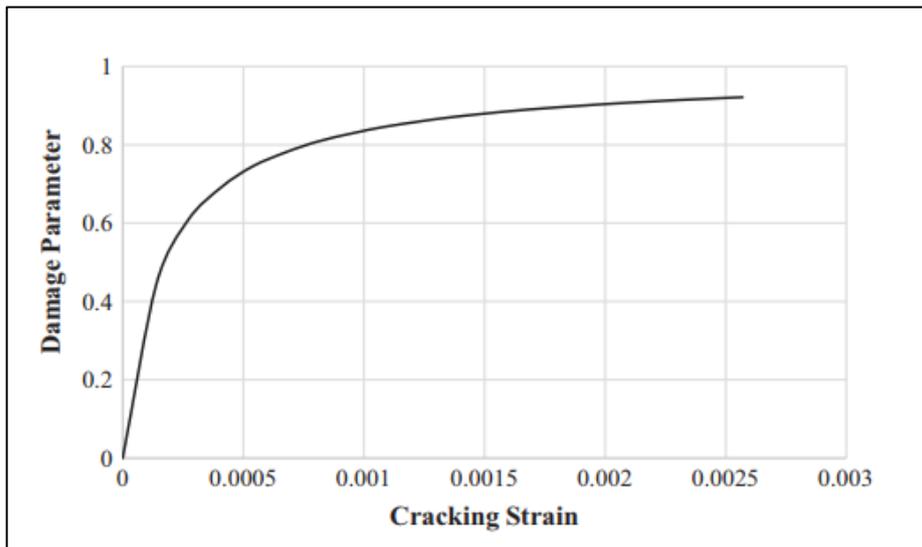
Figure 3.6: Damage parameter vs cracking strain (Hanif et al., 2016)

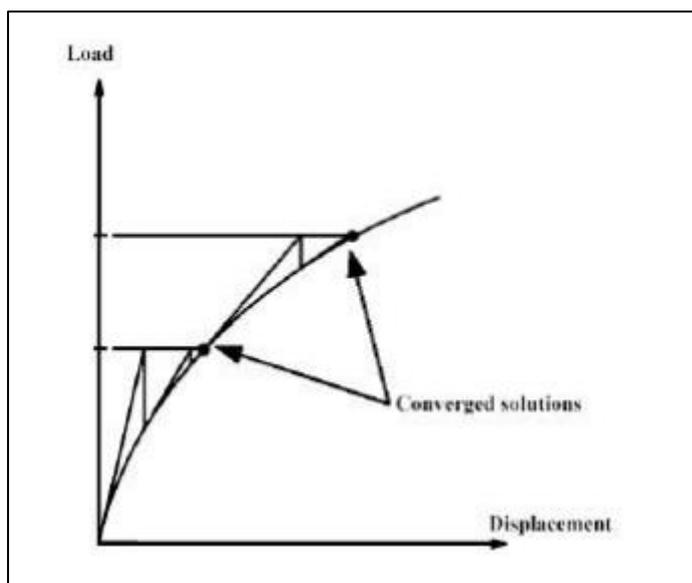
Figure 3.10: Newton-Raphson iteration in 2 load increments (ABAQUS 6.14)

In nonlinear analysis, the total load applied to a finite element model is divided into a series of load increments called “load steps”. When the solution is completed at each increment, the stiffness matrix of the model is updated to reflect nonlinear changes in structural stiffness before proceeding to the next load increment. The ABAQUS program uses Newton-Raphson equilibrium iterations for adjusting the model stiffness. The Newton-Raphson iterative method provides convergence at the end of each load increment within the specified tolerance limits. Figure 3.10(below) shows the use of the Newton-Raphson approach in a single degree of freedom nonlinear analysis. It assesses the out-of-balance load vector, which is the difference between the restoring forces (the loads corresponding to the element stresses) and the applied loads, prior to each solution. Subsequently, the program performs a linear solution, using the out-of balance loads, and checks the convergence. If the convergence criteria are not satisfied, the out-of-balance load vector is re-evaluated, the stiffness matrix is adjusted, and a new solution is accomplished. This iterative procedure continues until the problem converges.

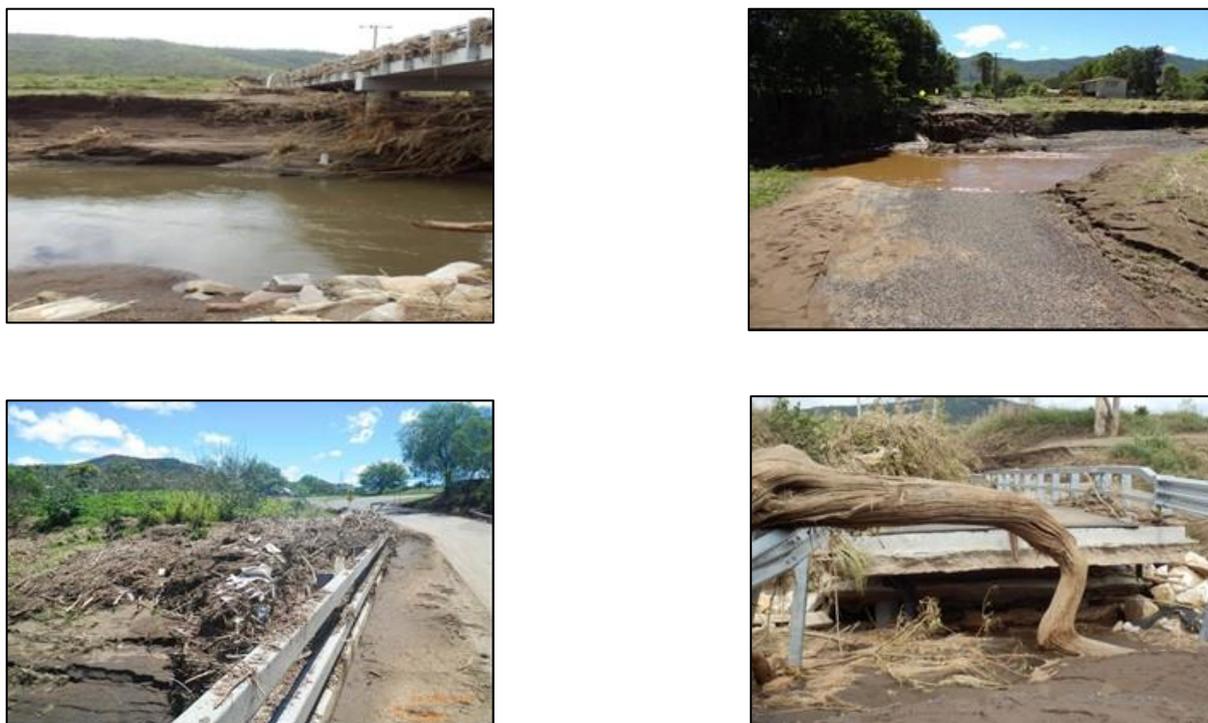
Figure 4.1: Some of the snap shots of the affected bridges

Lockyer Valley Regional Council in Queensland has compiled a comprehensive bridge inspection report for about 46 bridges in the region before they open the bridges for traffic after the flood has receded. The study on this report indicated that the damage to bridge structures are complex and requires a detailed knowledge of underlying design principles, current classification of roads/bridges as well as construction methods adopted during different periods of design and construction. Critical analysis of this bridge inspection data that included the photos of the affected bridges revealed that the failure of the bridges was primarily due to the flood impacts on the attributes of bridge such as bridge girders and decks, bridge approaches, relieving slabs, abutments, wing walls and misalignment of piers. The report also revealed that some of the bridges were inundated as long as 96 hours and the fill under the relieving slab had undermined. The impact load of the huge rocks, ship containers, vehicles and the other unexpected debris that were carried along the flood water with high velocity was the primary cause of damage to bridge superstructure, abutments, wing walls and piers. There are many ways that a bridge could be damaged in an extreme flood event. If the structure is completely inundated during the flood, the damage to the property depends on the length of time it was submerged as well as the elements collected around or passing the structure. Even after the flood water recedes, extra care should be taken to inspect the supports of the bridges. Approaches of a bridge could be damaged due to debris impact, settlement or depressions. Debris against substructure and superstructure, bank erosion and damage to scour protection will damage the waterways. Movement of abutments, wing walls, and piers, rotation of piers and missing, damaged, dislodged or poorly seating of the bearings are the major reasons for substructure failure. Superstructure could be damaged due to the debris on deck, rotation of deck, dipping of deck over piers or damage of girders due to log impact. Due to any of these reasons, the members of a bridge could be damaged and bridge may not be completely functional. Some of the snap shots of the affected bridges are illustrated in Figure 4.1.

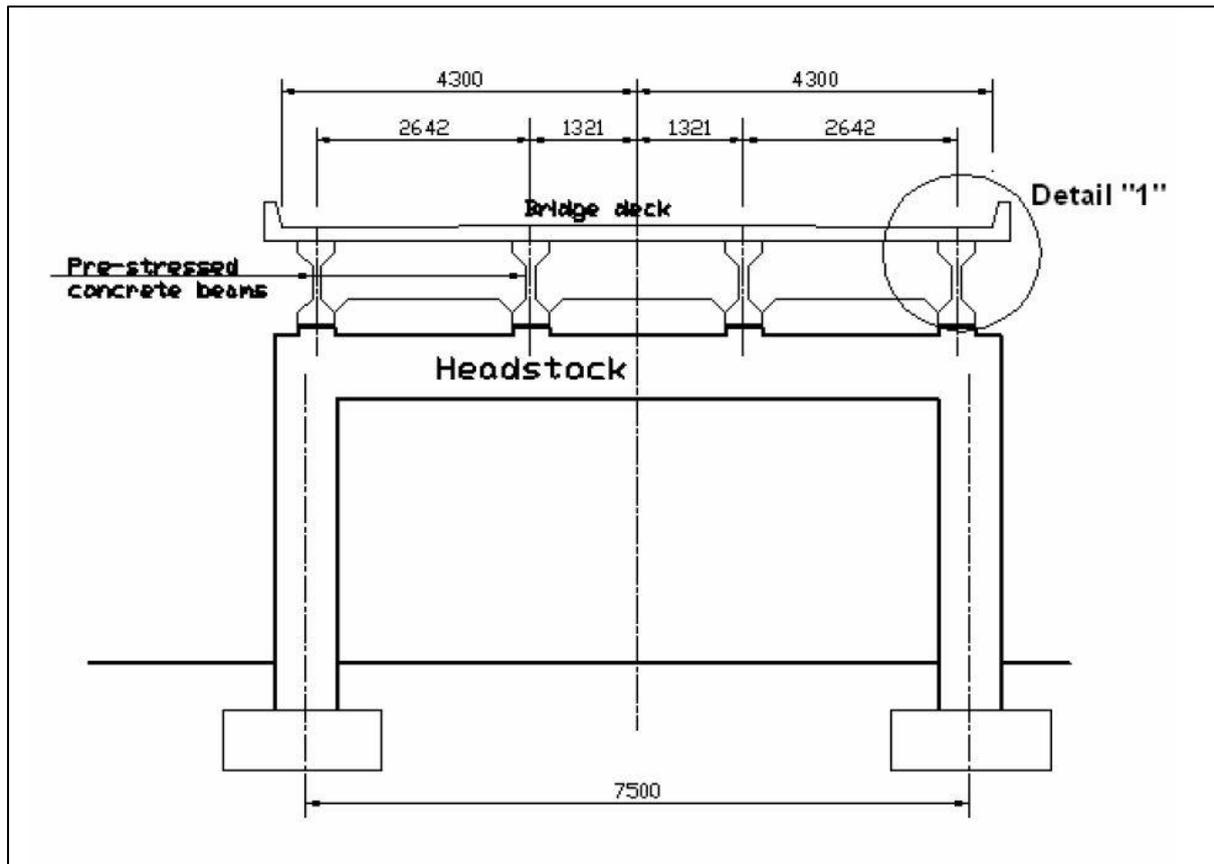
Figure 5.5 Schematic Details of the Headstock and superstructure

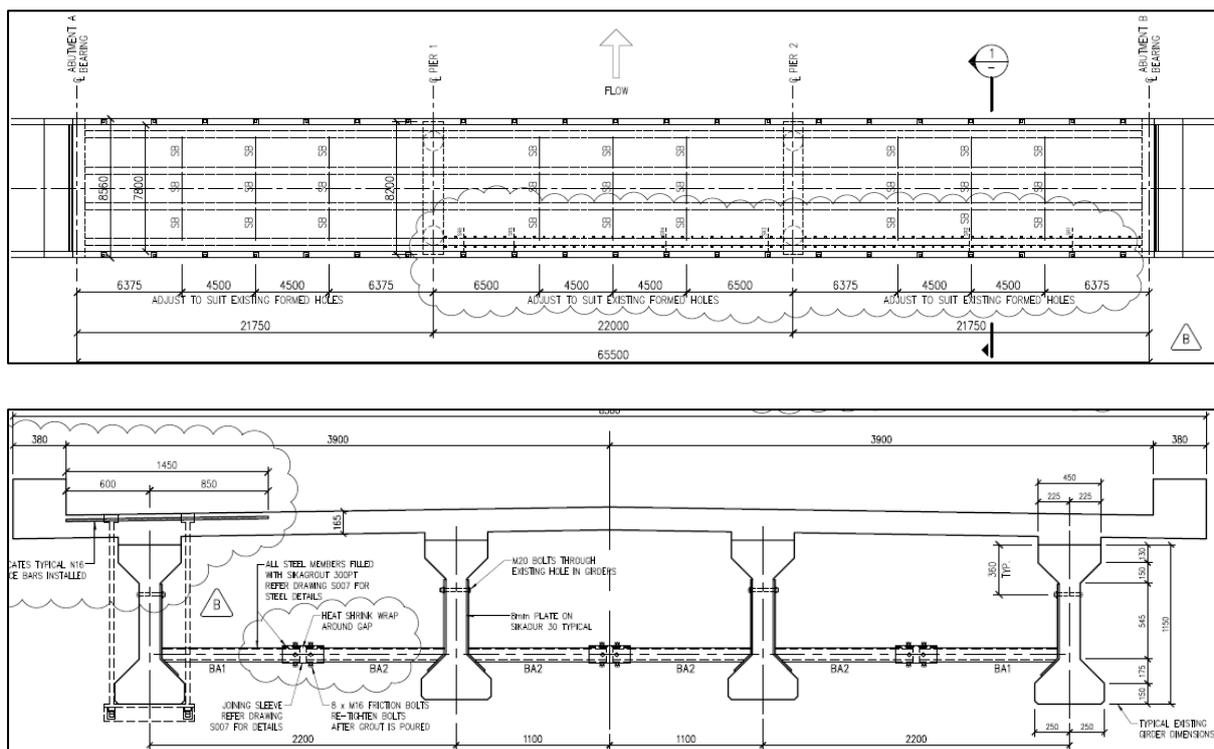
Figure 5.8: Kapernicks bridge sectional view

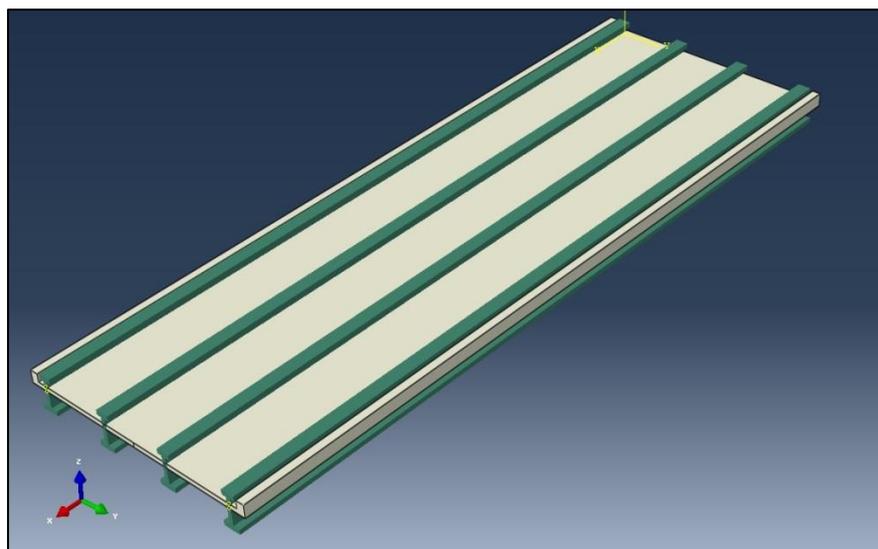
Figure 5.9: Rendered view of the I girder beam profile

In this simple method, Bridge I girder was modelled using ABAQUS two-node beam elements (B31). Corresponding section bending moment (SM2) output was requested from the field output request. Maximum flood induced bending moment at the mid-span section was derived for calculating the relevant damage indices. Figure 5.9(below) shows the rendered view of the I girder beam profile.

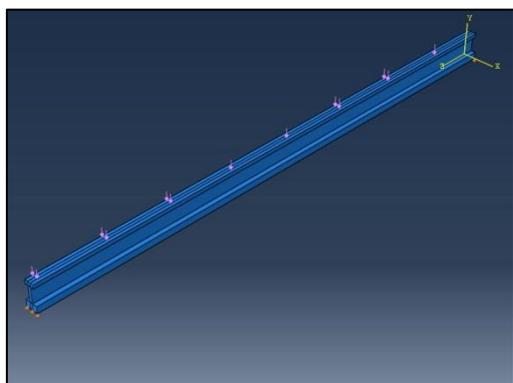
Figure 5.12: Simply supported Bridge Girder

Since no direct bending moment output is available for solid elements in any FEA, relevant elemental normal stress (S11) at the mid-span section of the beam were derived from the ABAQUS post processing step. These elemental stresses were then used to calculate the bending moment as discussed in 3.3.5.3. Neutral axis of the section was located in between where the stress value changed its sign from tensile to compressive or vice versa. Pinned and fixed support boundary conditions were considered here as well. Figure 5.11 and Figure 5.12 show the beam considered for the calculation of bending moment. Table 5-2 and Table 5-3(below) illustrate the stress obtained from ABAQUS analysis and the corresponding bending moments calculated. The results indicate that a 99.9% close estimation for pinned support condition whereas it gives 99.5% close estimation for fixed support condition and hence validate the method adopted. It should be noted here that Figure 5.11 and Figure 5.12 depicts just a single girder arrangement in the ABAQUS modelling for verification purpose of the method used to calculate bending moment from elemental stress output. However, in the actual modelling of the selected two case study bridges, all 4 girders and the deck on top of them were modelled and the mid span stress output from the end girder was considered for moment calculation since the mid span would experience the maximum bending moment. Also the flood load was applied laterally to the girder to simulate the actual impact.

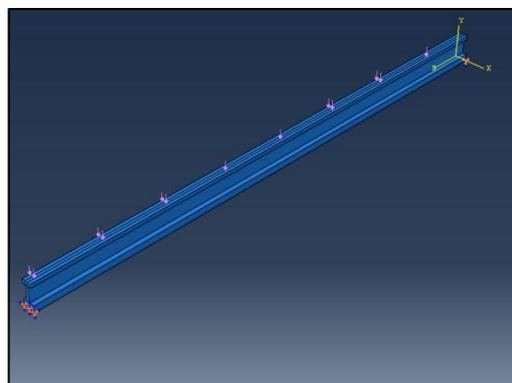
Figure 5.11: Fixed supported Girder

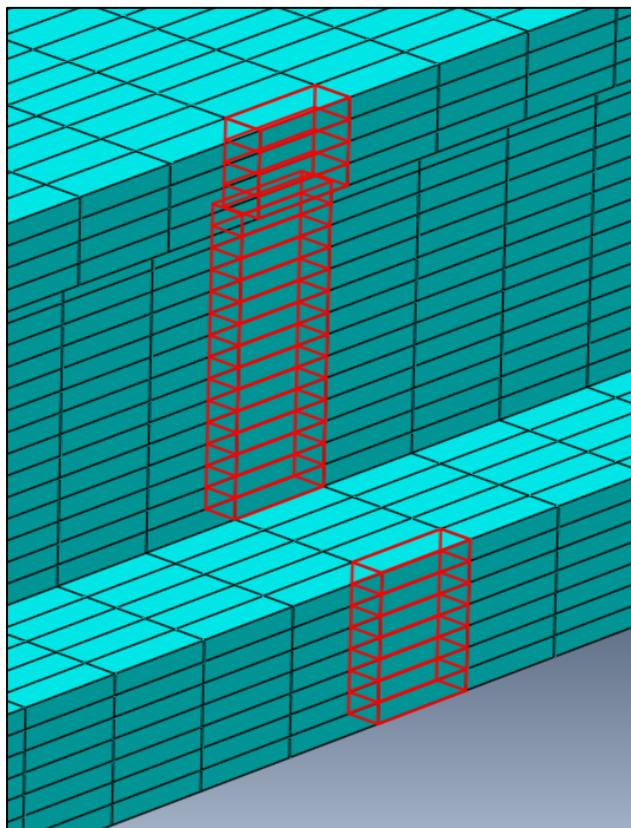
Figure 5.13: Considered mid-span elements

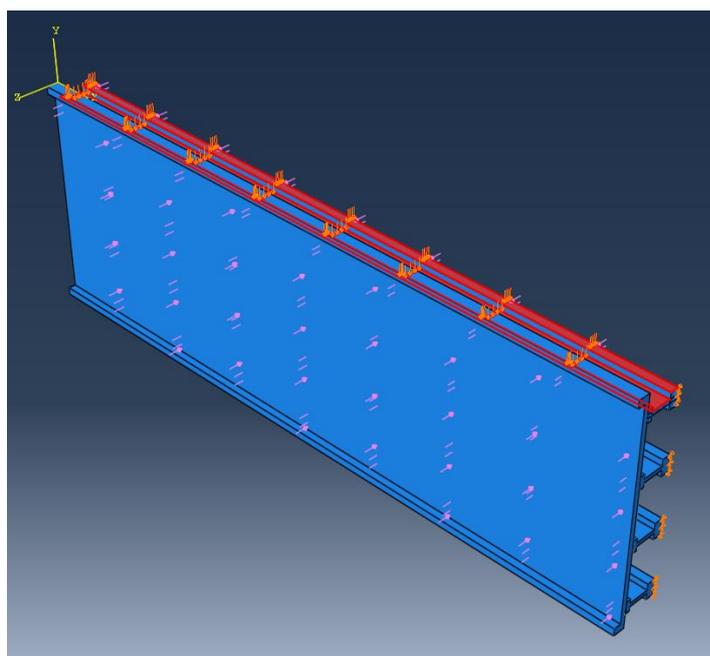
Figure 5.16: ABAQUS bridge Deck Model

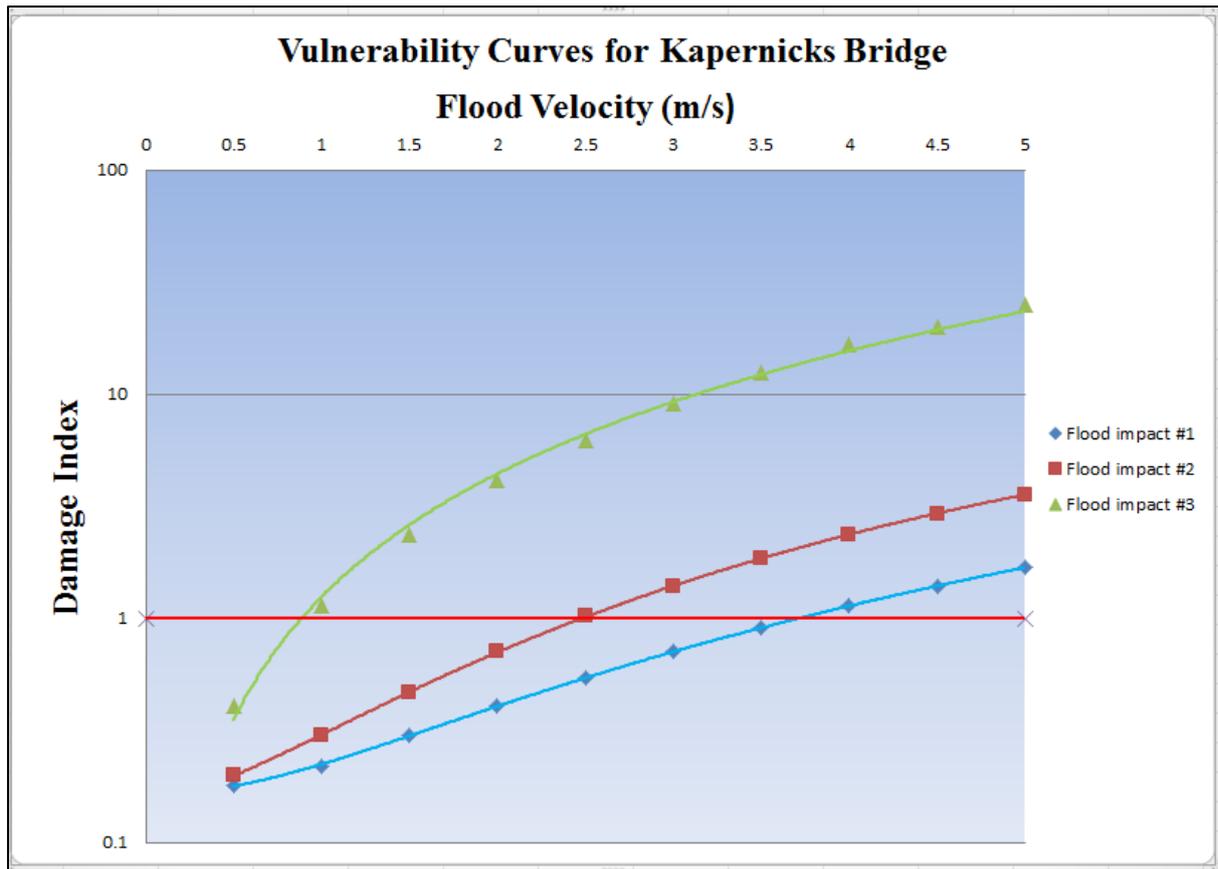
Figure 5.17: Vulnerability curves for Kapernicks bridge

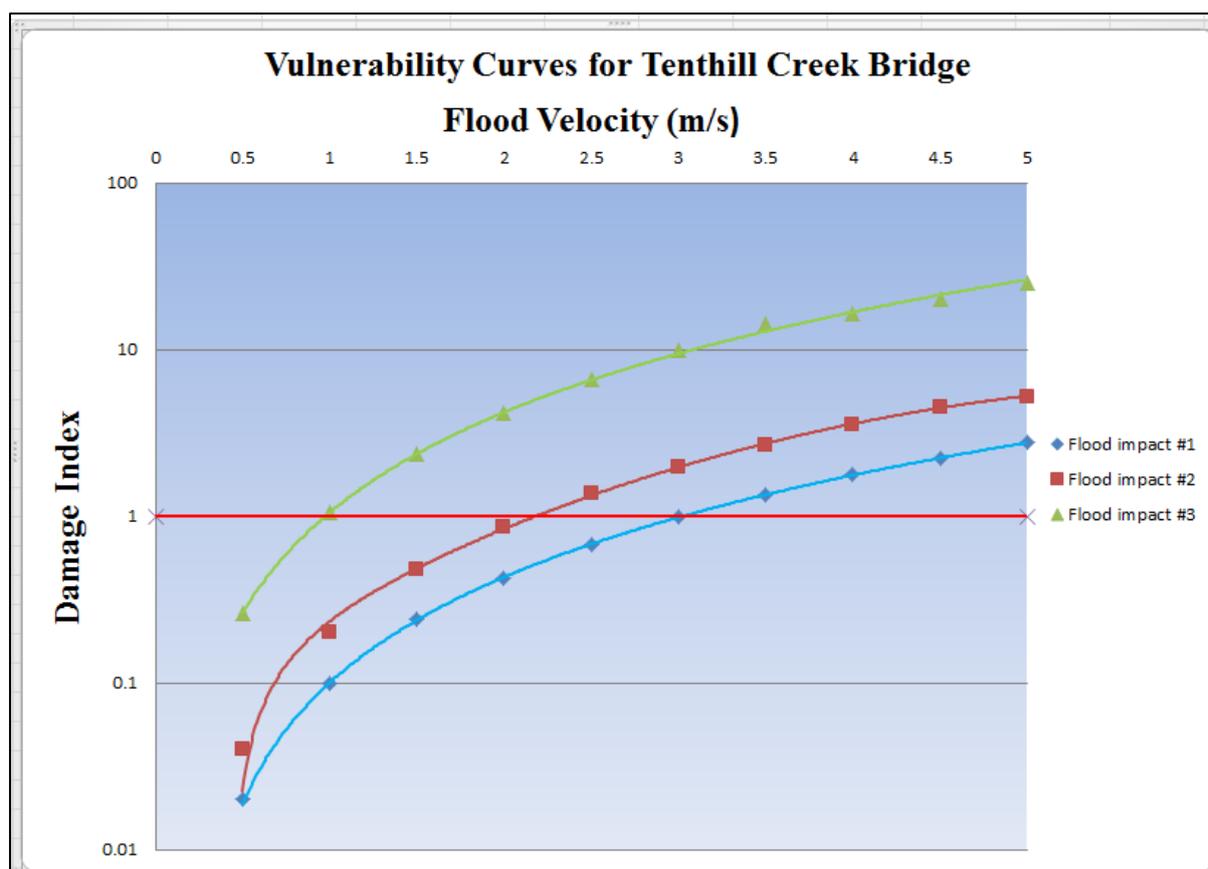
Figure 5.18: Vulnerability curves for Tenthill Creek bridge

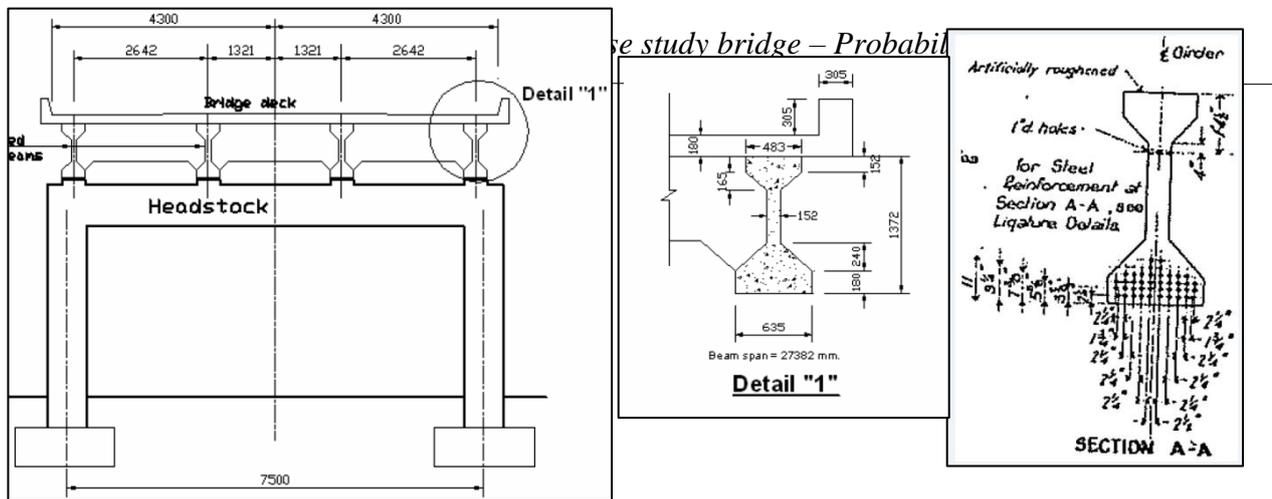
Figure 6.3: Section detail of the bridge deck and girder

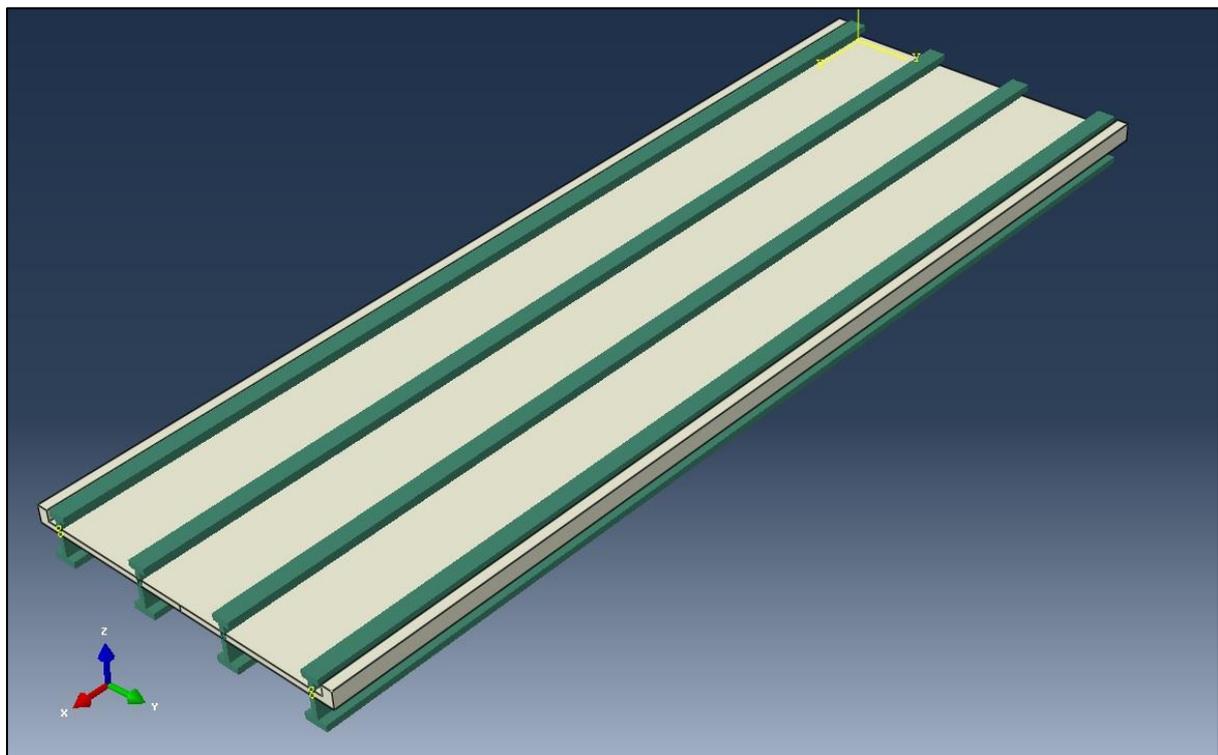
Figure 6.4: ABAQUS Bridge Deck Model

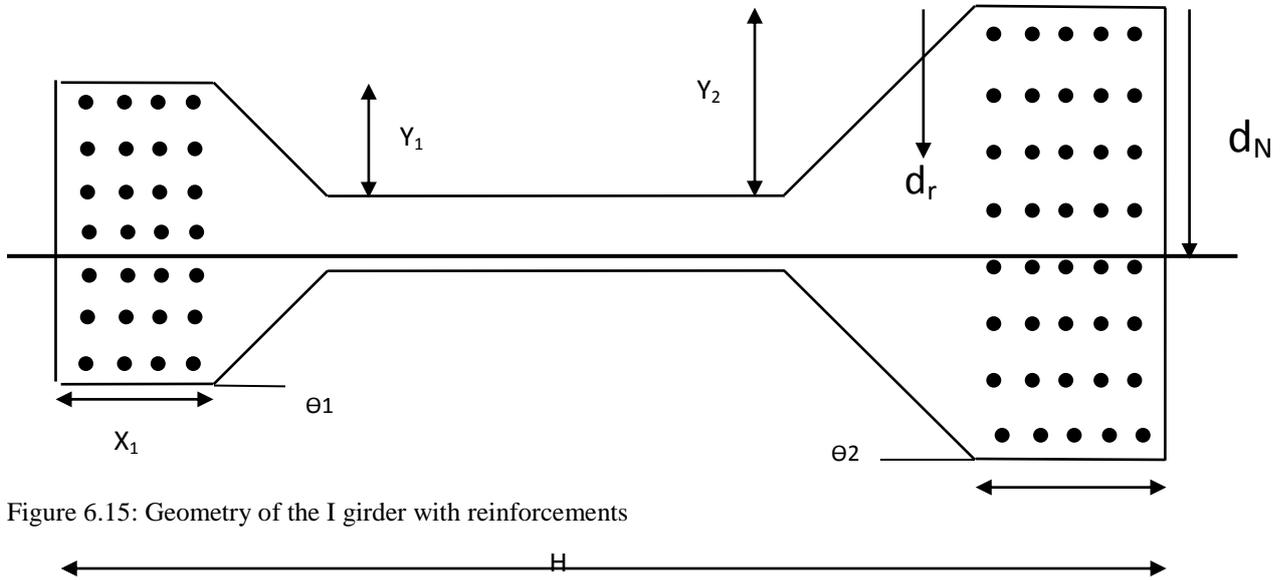
Figure 6.15: Geometry of the I girder with reinforcements

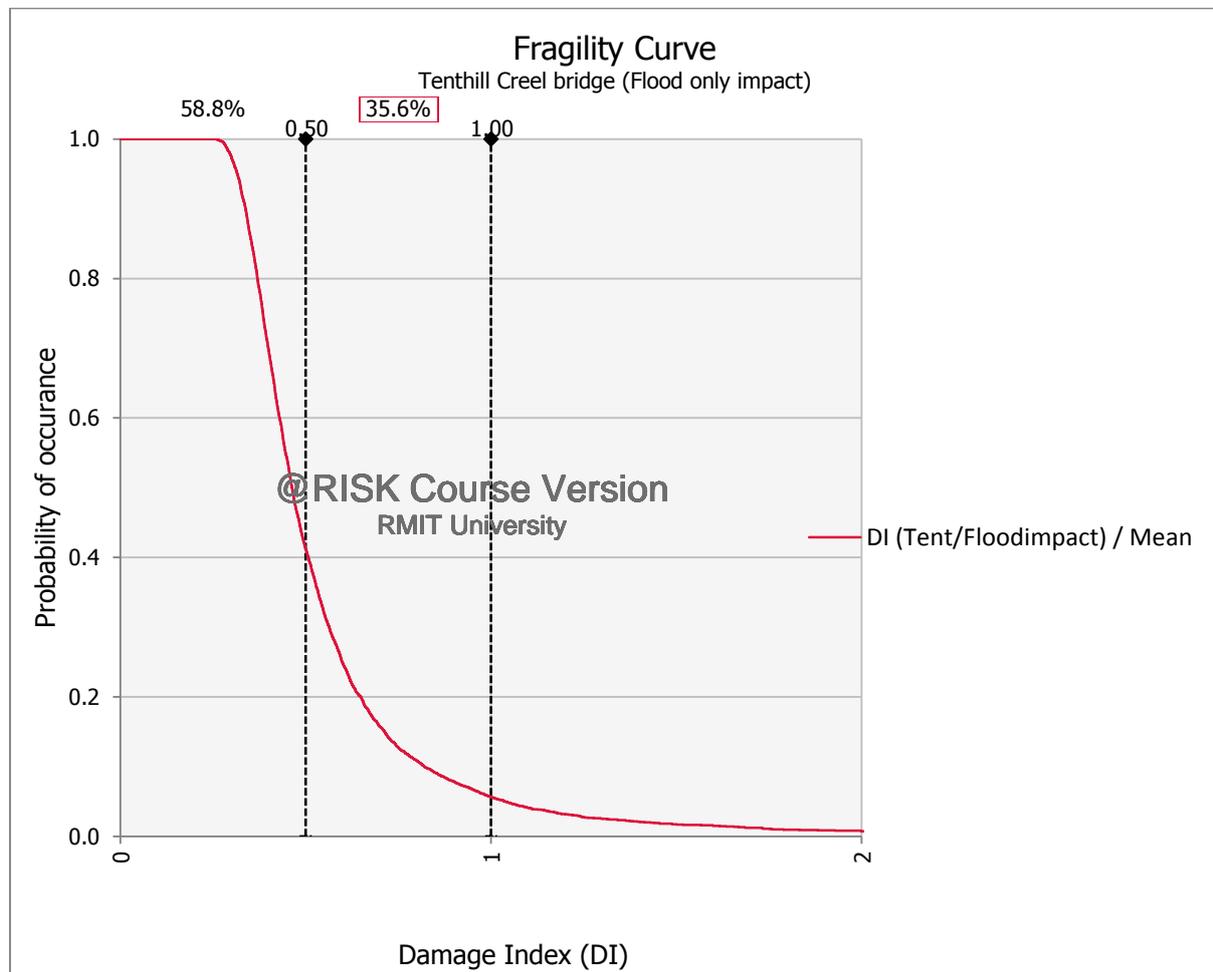
Figure 6.17: Fragility curve for Tenthill Creek Bridge under flood only impact
