**SYNTHETIC DAMAGE CURVES FOR CONCRETE GIRDER  
BRIDGE DECKS UNDER FLOOD HAZARD**

**Doctor of Philosophy**

RMIT University

October 2017

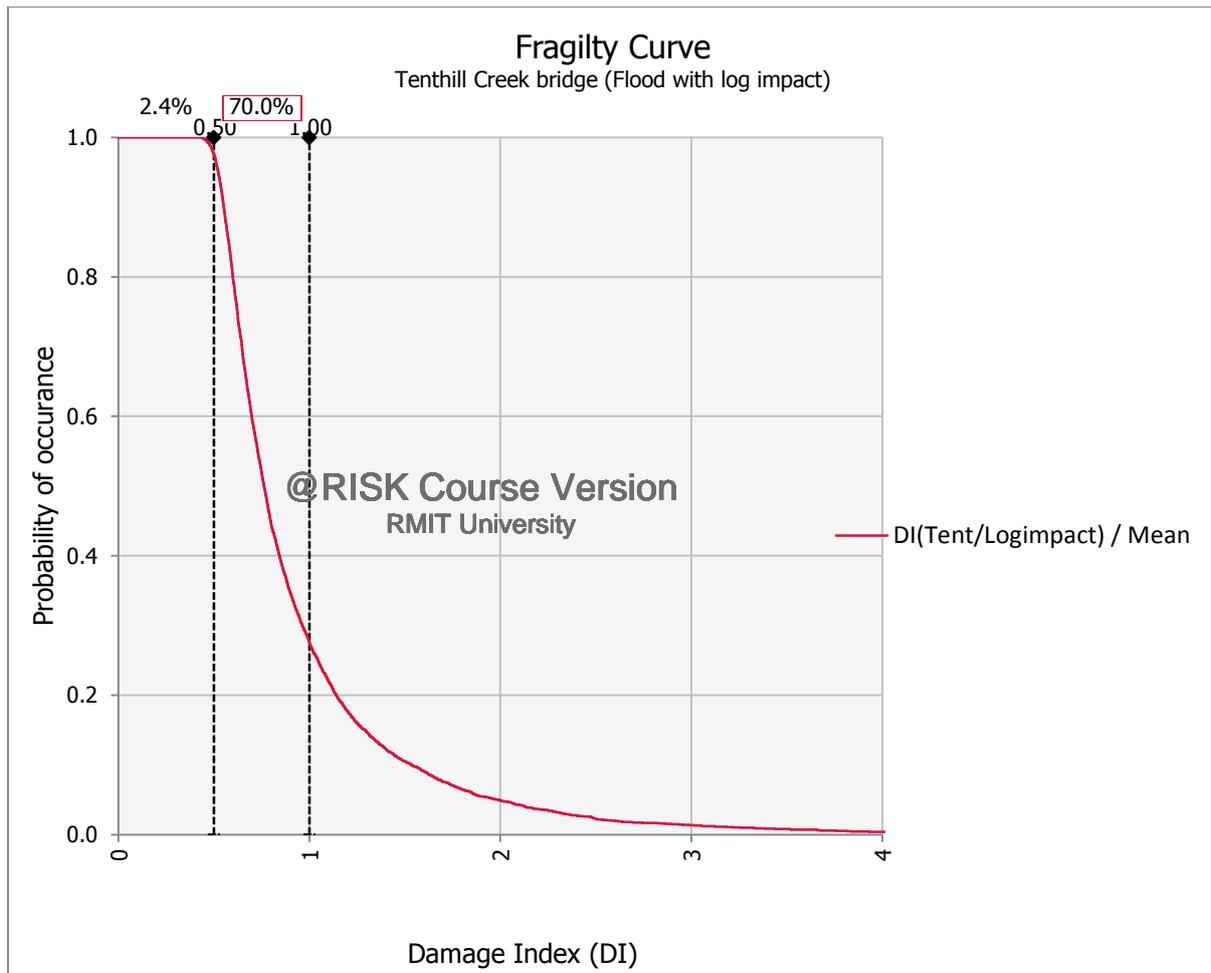
Figure 6.18: Fragility curve for Tenthill Creek Bridge under flood and log impact

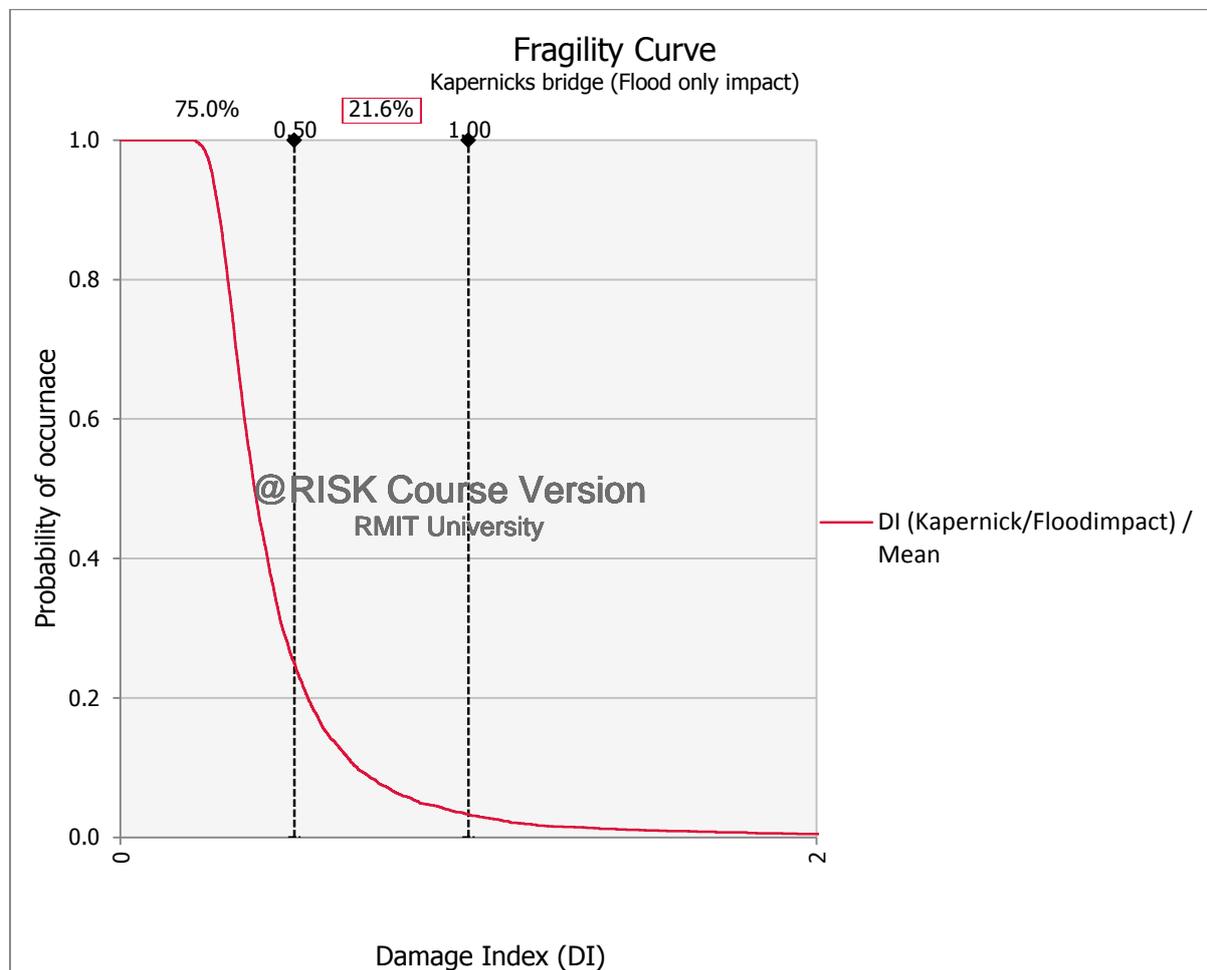
Figure 6.19: Fragility curve for Kapernicks Bridge under flood only impact

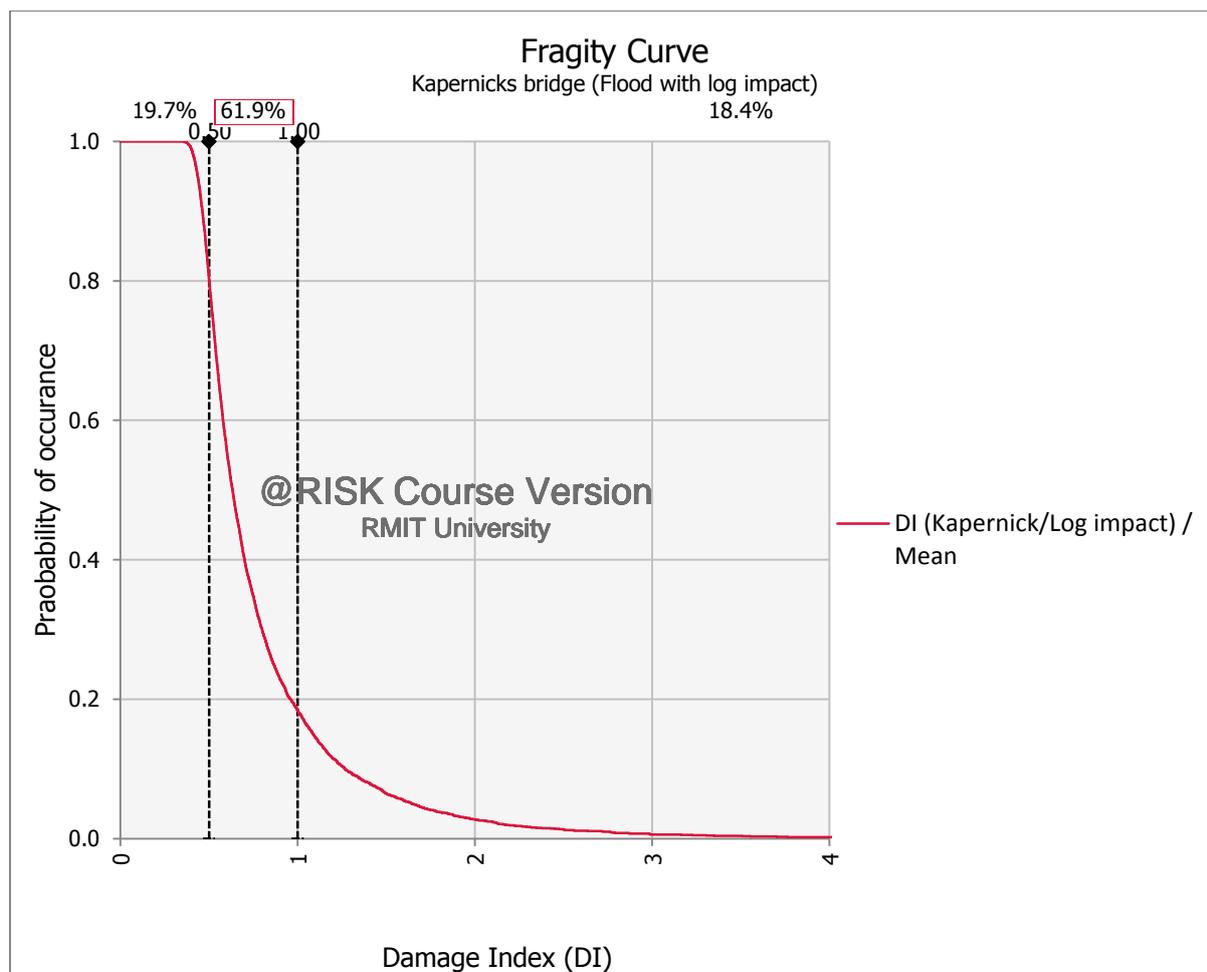
Figure 6.20: Fragility curve for Kapernicks Bridge under flood and log impact

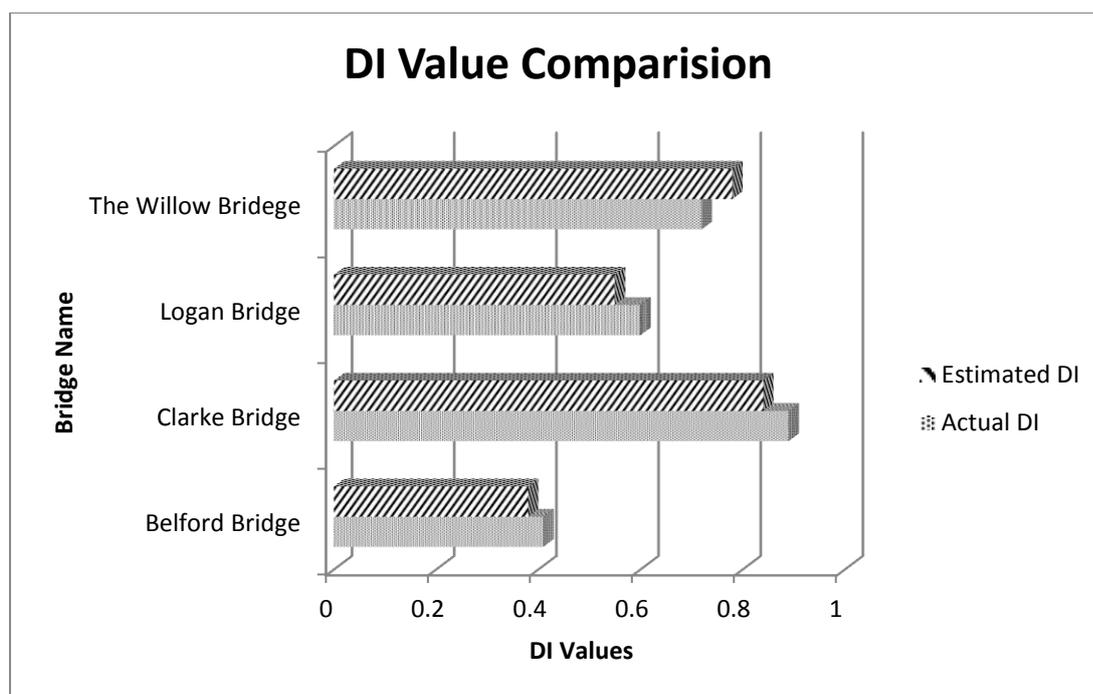
Figure 7.1: Comparison of Actual DI and Estimated DI

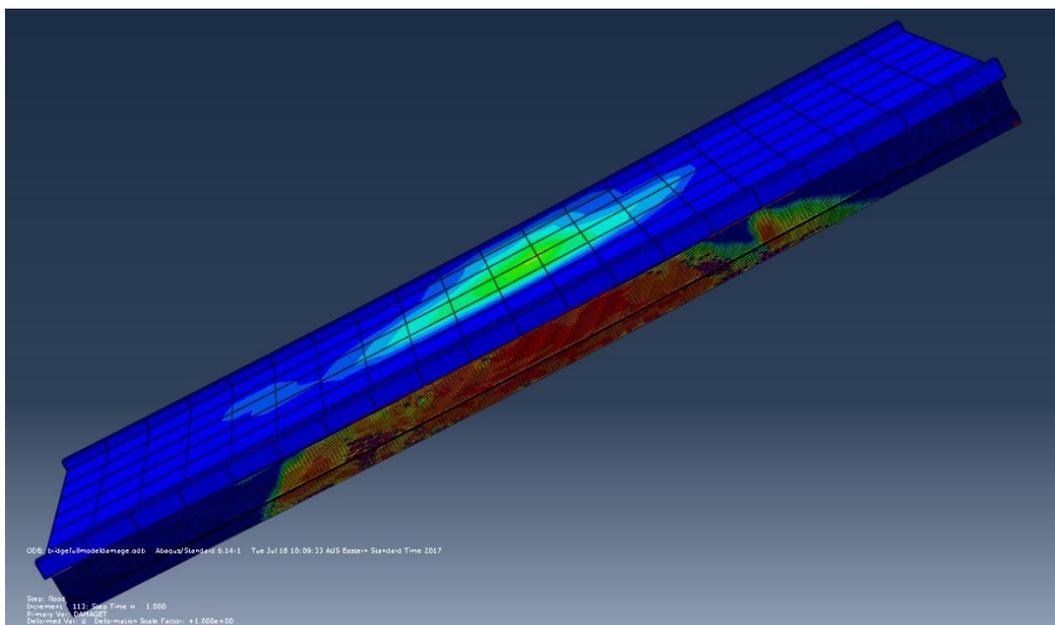
Figure 7.3: Concrete Tension Damage Parameter ( $dt$ )

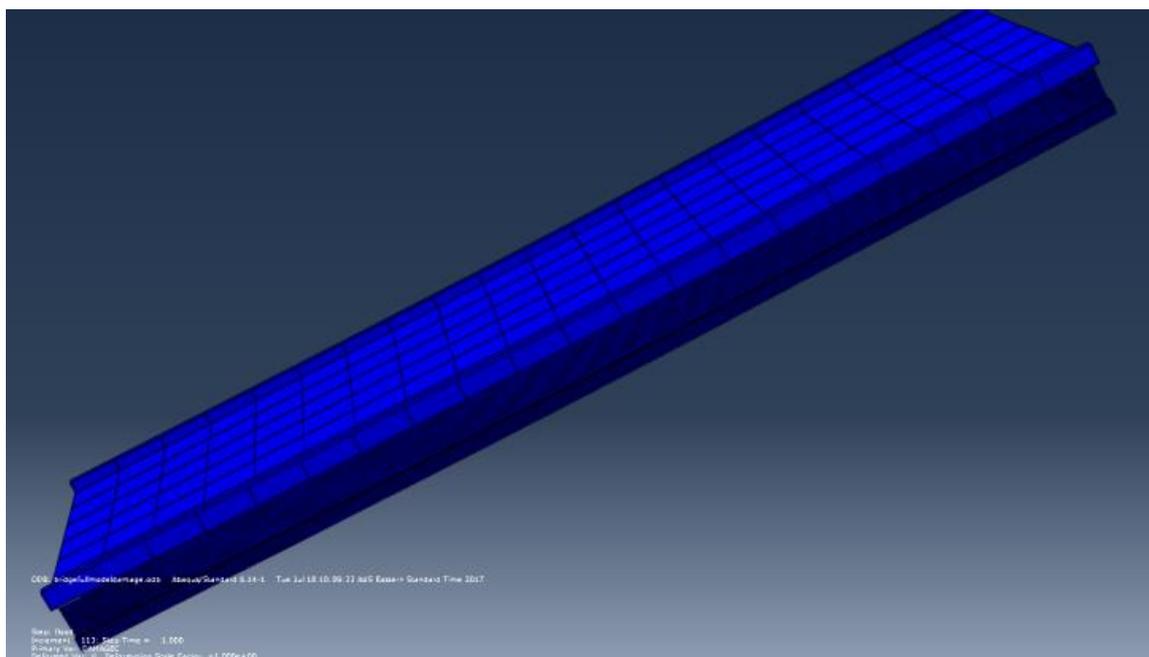
Figure 7.4: Concrete Compression Damage Parameter ( $d_c$ )
