LOAD REDISTRIBUTION AND PROGRESSIVE FAILURES OF BATTEN TO RAFTER CONNECTIONS UNDER WIND LOADING

Korah Parackal

Cyclone Testing Station, James Cook University, QLD

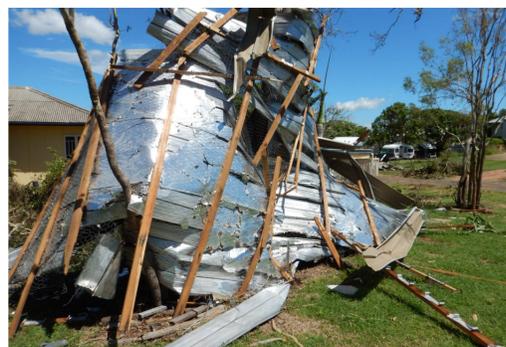
Batten to rafter failure caused by Tropical Cyclone Marcia

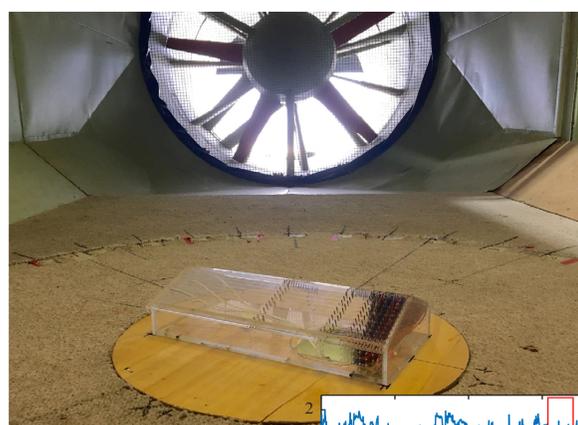
Fig1. Wind tunnel model and recorded load fluctuations

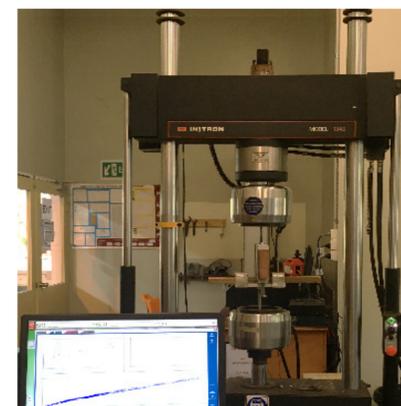
■ Connection samples are tested under fluctuating loads

Fig2. Connection testing apparatus and connection response

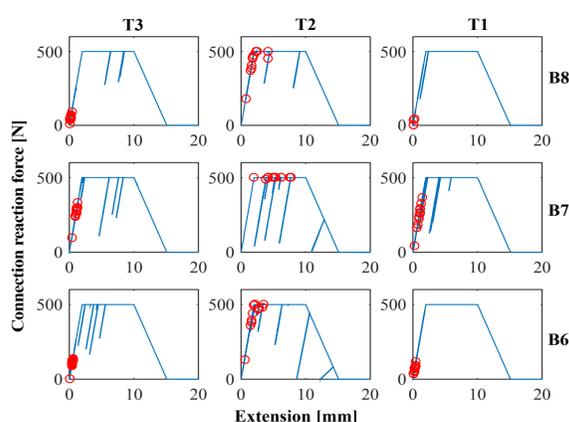
Fig4. Force-displacement behaviour of connections in the model showing nail slips and load redistribution

■ Model outputs include load sharing and progressive failure information

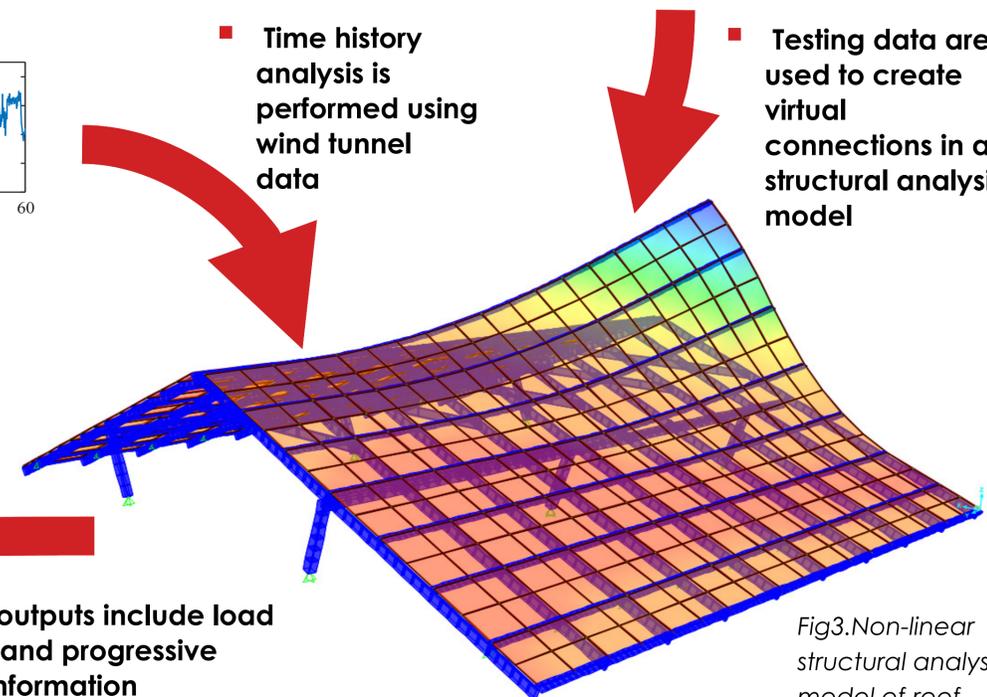
■ Testing data are used to create virtual connections in a structural analysis model

Fig3. Non-linear structural analysis model of roof structure
