DUNGONG FLOOD 20-21 APRIL 2015

Post-flood damage survey

Dungog Flood, 20–21 April, 2015

GEOSCIENCE AUSTRALIA
RECORD 2015/21

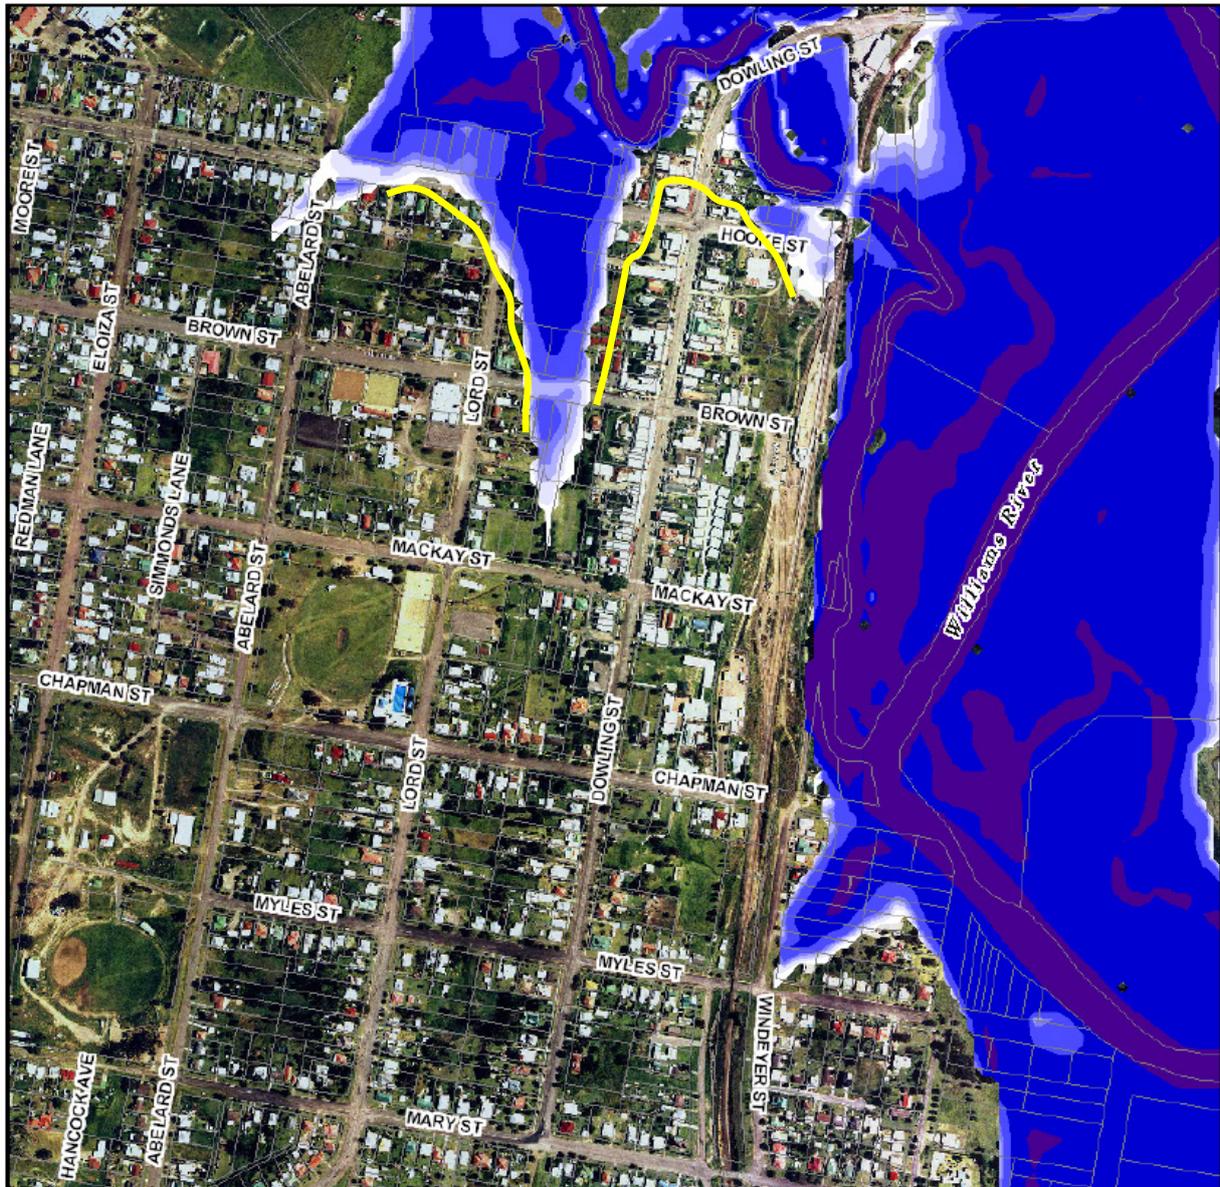
Figure 2.6 and Figure 2.7 show extracts from a flood study undertaken for the Williams River (BMT WBM, 2009) for the 0.5% AEP Flood Event and the Probable Maximum Flood (PMF) Event respectively. The yellow lines superimposed on the images represent the high water level for the 20-21 April, 2015 event derived from field observations, interviews with residents and photos supplied by Dungog residents. They suggest that the 2015 event exceeded a 0.5% AEP event but was significantly below a PMF event.

Figure 2.6 Extract from BMT WBM (2009) showing modelled flood extents for the 0.5% AEP Flood Event. The yellow lines superimposed on the images represent the high water level for the 20-21 April, 2015 event derived from field observations, interviews with residents and photos supplied by Dungog residents.

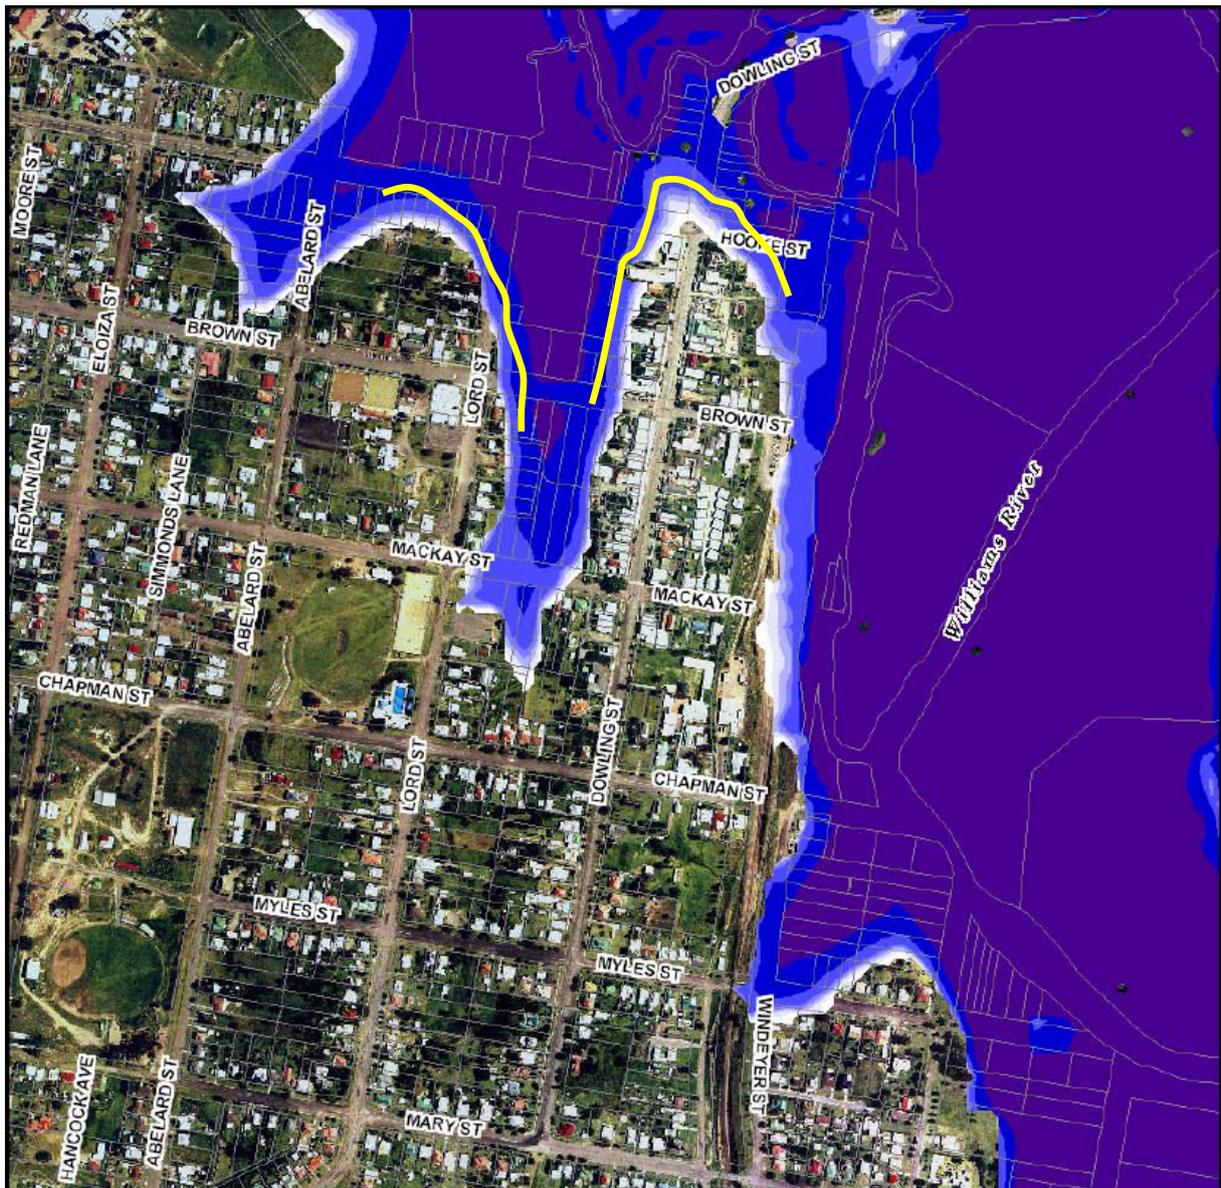
Figure 2.7 Extract from BMT WBM (2009) showing modelled flood extents for the Probable Maximum Flood Event. The yellow lines superimposed on the images represent the high water level for the 20-21 April, 2015 event derived from field observations, interviews with residents and photos supplied by Dungog residents.

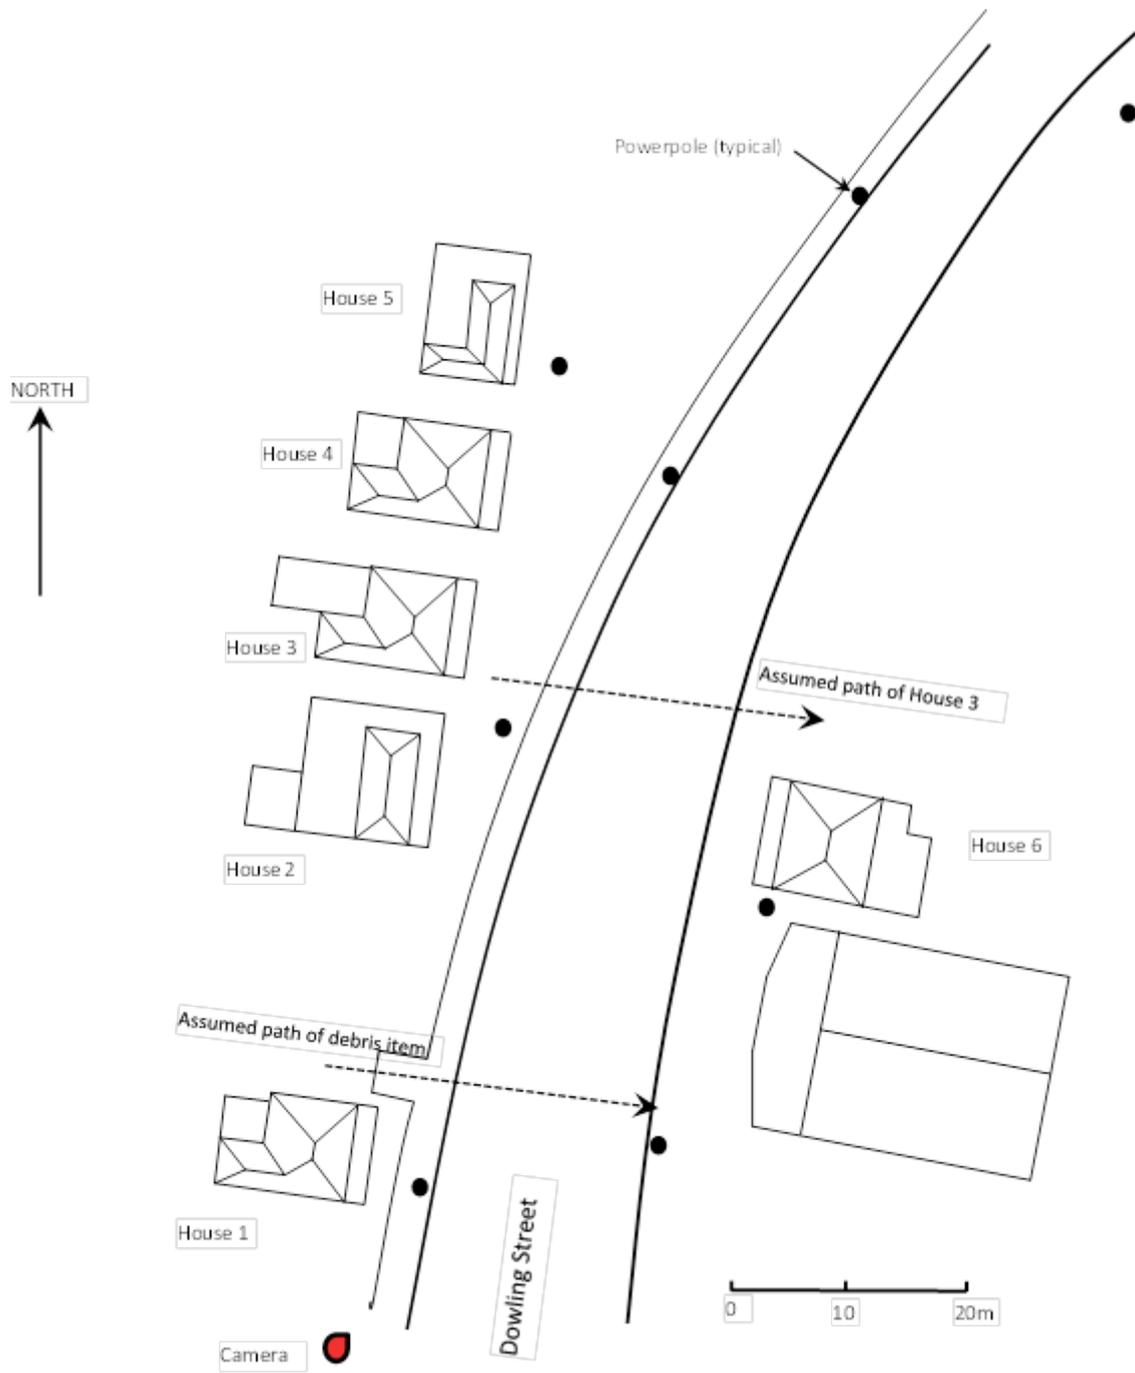
The fast flowing floodwaters impacted six houses at the north end of Dowling Street. These houses are indicated in Figure 4.2. All the houses appear to have had similar superstructure characteristics; comprising metal sheet roofing, hardwood timber framing, weatherboard external wall cladding and hardwood timber framed floors. The substructure of Houses 1, 2, 3 and 6 appears to have been brick piers, the substructure of House 4 was low level timber stumps and that of House 5 was tall timber stumps or piers. Images of the surviving parts of the houses are provided in Figure 4.3 to Figure 4.9 and the flood impacts summarised in Table 4.1. In addition, four other houses at the north end of Dowling Street were affected by inundation, apparently without velocity-related damage. Floodwaters also impacted houses in Hooke Street and Brown Street where approximately 30 other houses incurred inundation damage from comparatively slow moving water.

House	State after flood	Discussion
1	Intact, however suffered inundation damage to a depth of about 0.7m above floor level.	House was possibly floated as evidenced by displaced antcaps that would have been located between pier tops and underside of bearers.
2	Destroyed.	Debris observed moving downstream in Youtube, 2015
3	Floated and washed away.	House observed being washed away in Youtube, 2015
4	House severely damaged and moved off supporting stumps.	
5	House destroyed.	Evidently taller timber stumps failed under lateral loading from moving water.
6	House destroyed.

Figure 4.2 Sketch map of north end of Dowling Street, Dungog, showing estimated location of camera (red dot) used to record Youtube (2015) and relevant features visible in the video.

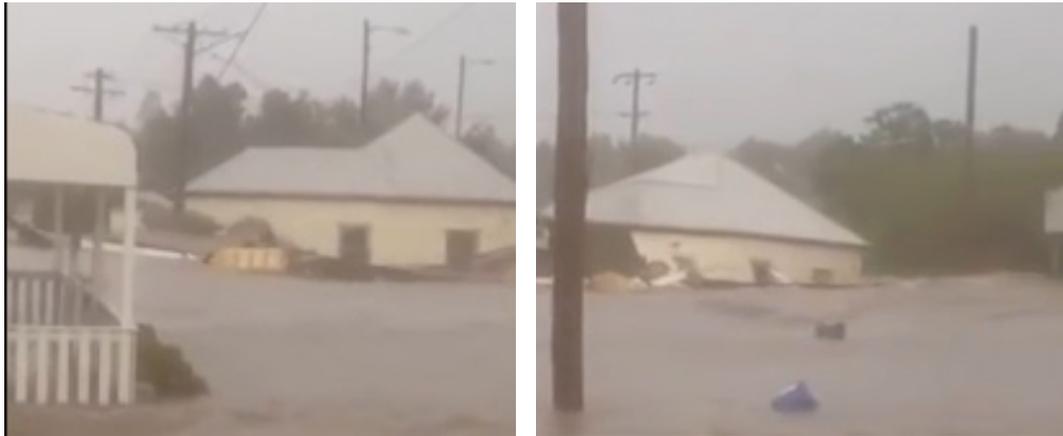
Figure 4.10 Two stills taken from Youtube (2015) at 26 seconds and 35 seconds after commencement of video. The two stills show where the near rear corner of House 3 crosses sight lines between the camera and power poles.

Using the two pairs of images in Figure 4.10 and Figure 4.11 estimates of water velocity were obtained. House 3 in Figure 4.10 was estimated to have travelled 19.7m in 9s yielding a velocity of 2.2m/s. The debris item in Figure 4.11 was estimated to have travelled 5.6m in 3s yielding a velocity of 1.9m/s. Qualitatively, in the video the water appears to be travelling faster at the house than closer to the camera which matches these numerical results. The chief uncertainty in calculating the water velocity by this method is with estimating the distance that a floating item has travelled in the time period. Although times are known for objects crossing sight lines from the camera the distance of objects from the camera are not known precisely and hence need to be estimated. In this instance the house was assumed to have travelled parallel to its long axis (roughly at right angles to Dowling Street). The debris item was assumed to be traveling parallel to House 3 but immediately north of House 1 as shown in Figure 4.2.

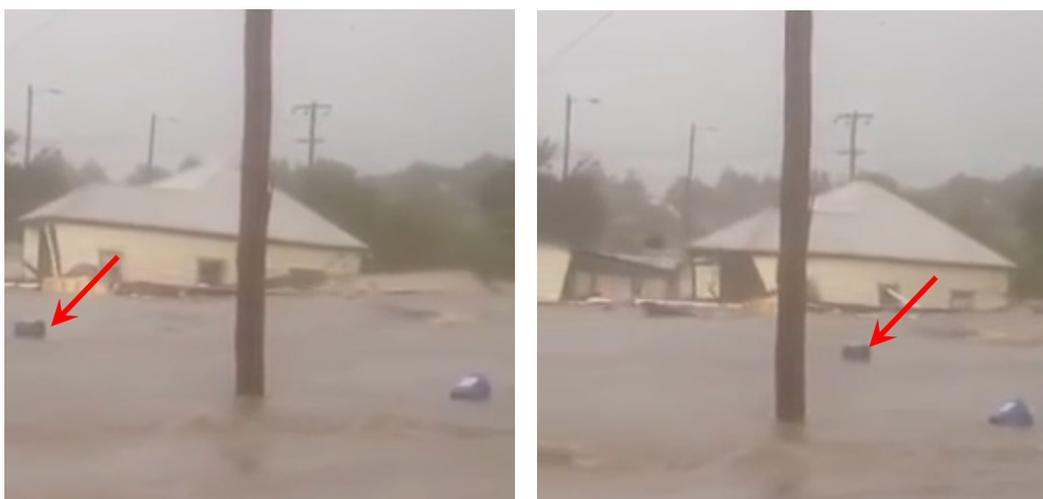
Figure 4.11 Two stills taken from Youtube (2015) at 31 seconds and 34 seconds after commencement of the video. The two stills show where the debris item, arrowed, crosses sight lines between the camera and power poles.

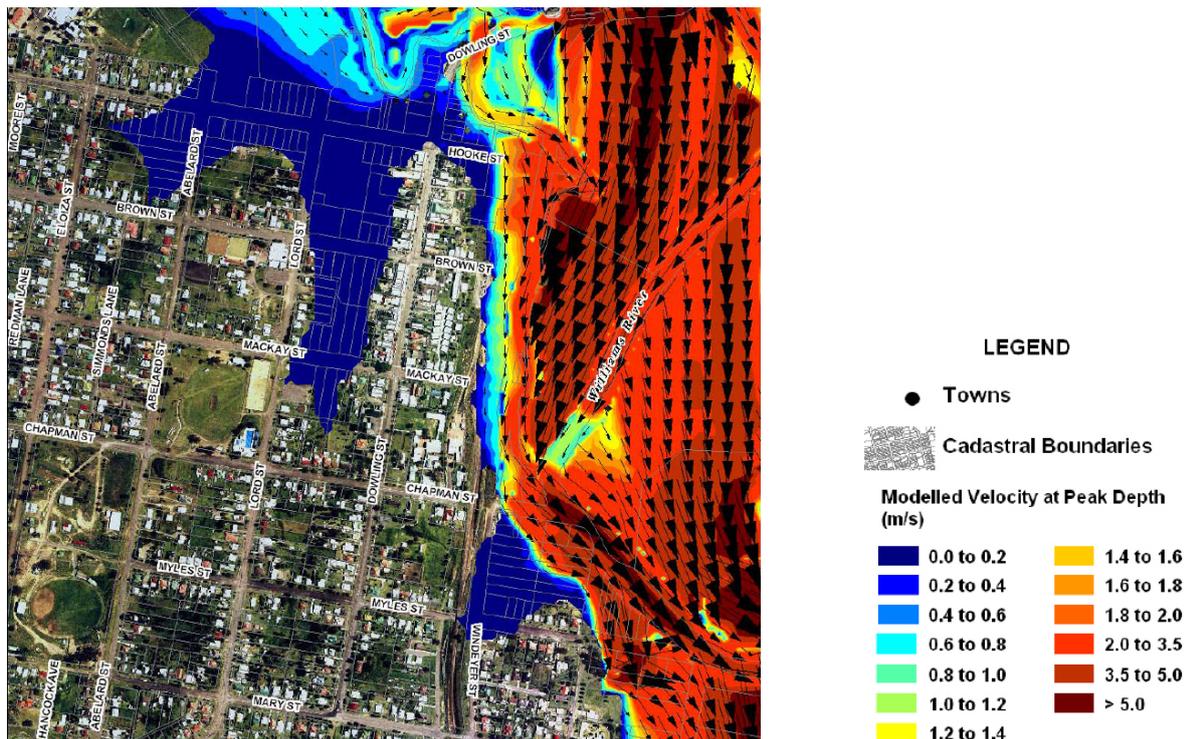
The calculated flow velocities were also compared to the current flood study for the Williams River (BMT WBM, 2009). The values above were consistent with modelled main stream velocities in Myall Creek shown in Figure 4.12 although they exceed the modelled velocities over Dowling Street. It is important to note that each flood is different at local scales and hence it is unlikely that the flood of 20-21 April, 2015 exactly matched the flood event modelled to produce the results in Figure 4.12. Furthermore, there are uncertainties associated with all flood modelling.

Figure 4.12 Extract from BMT WBM (2009) showing modelled velocities for a PMF Event.

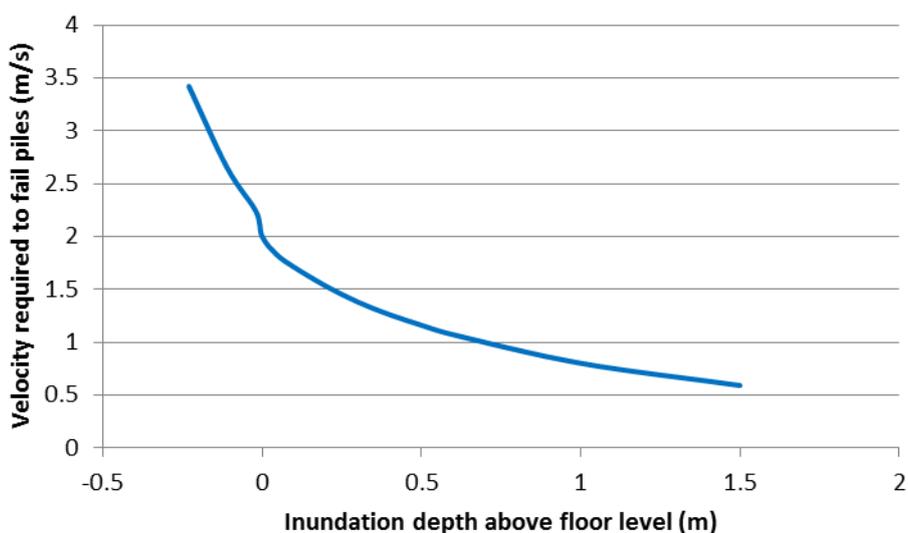
The only remains of House 5 were the failed timber stumps visible in Figure 4.8. An attempt was made to estimate the likely depth and velocity of water that destroyed this house. In making this estimate the failure mode of the timber stumps needs to be determined. In this case, the absence of disturbance of the soil around the stumps, such as may have resulted from a short laterally loaded pile type failure, suggested a simple overturning failure mechanism. Drag from the flowing water was calculated as per AS 5100.2-2004 (Standards Australia, 2004) and allowance made for buoyancy effects. The resulting velocity versus depth required for failure of the supporting stumps is shown in Figure 4.14.

Figure 4.14 Graph of velocity versus depth of inundation above floor level required to fail the supporting stumps of House 5. The deviation from a smooth curve at inundation depths just below floor level is due to a rapid increase in buoyancy force as the floor framing becomes immersed.

A photograph in Sansom (2015) taken looking southwest across the Myall Creek bridge at about the time flood waters reached maximum depth, shows House 4 in place but House 3 and House 5 missing, suggesting that House 5 was washed away before flood waters reached their maximum depth. Assuming that House 5 had already been destroyed by the time House 3 was washed away as shown in Youtube (2015) the water velocity would have been lower than the 2.2m/s value derived from Youtube (2015). This suggests that House 5 failed when the water was about 0.3m above floor level (about 2m above ground level) and flowing at about 1.5m/s. It appears that in this case the presence of tall stumps has negatively influenced the strength of the house to resist water induced loads.

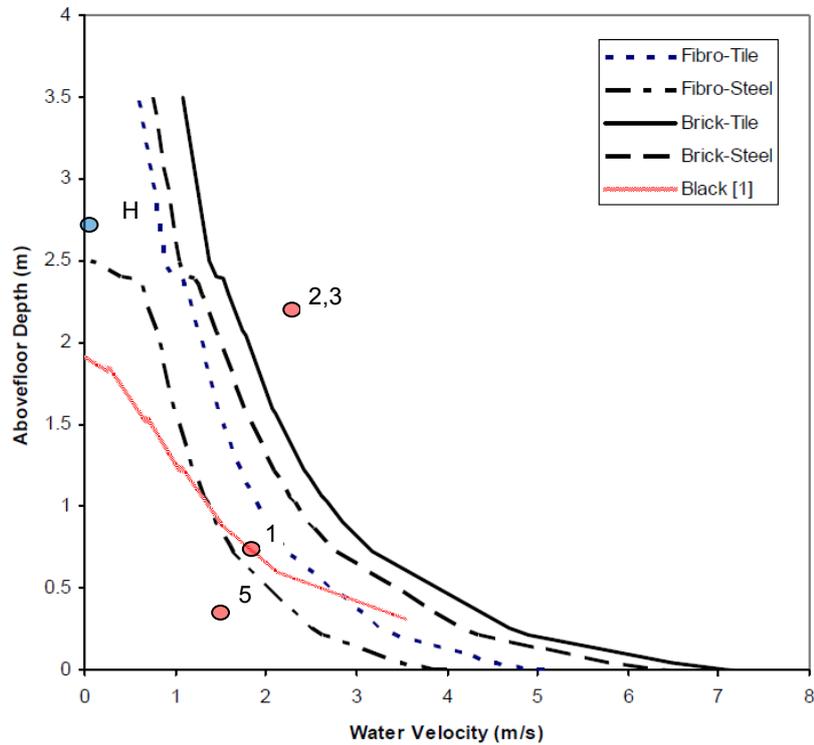
The velocity and depth estimates for Houses 1, 2, 3 and 5 are plotted against published failure thresholds in Figure 4.15 and Figure 4.16. The curves in Figure 4.15 include those developed by Black (1975) for light timber framed residential construction. The work by Black was later refined and applied to Australian construction (Dale et al, 2004) which is also presented in the figure. The more generalised relationships developed by Smith et al (2014) and McLuckie et al (2014) are presented in Figure 4.16. The estimates indicate that the published threshold curves are reasonable for low-set timber framed houses on low stumps or piers and suggest that houses of similar construction on tall piers or stumps may be more vulnerable than indicated by the published threshold curves.

Figure 4.15 Extract from Dale et al (2004) showing thresholds for building stability for Australian house types. Results from this study are shown as red dots with identifying house numbers. Note that House 5 was a high-set house compared to Houses 1, 2, 3. The blue dot labelled 'H' is the data point for the house on Hooke Street that was not floated.

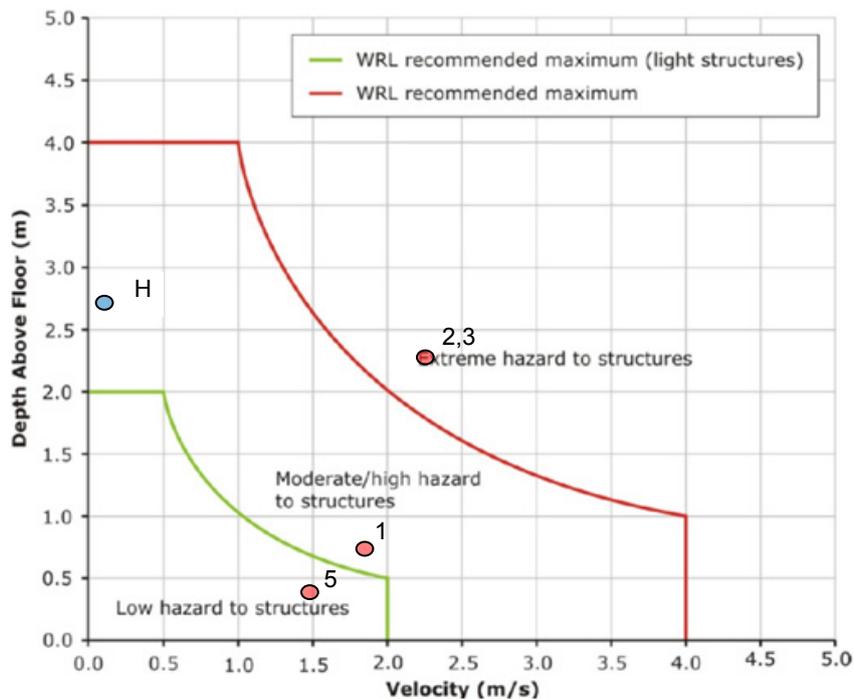
Figure 4.16 Extract from Smith et al (2014) and McLuckie et al (2014) depicting thresholds for building stability in floods for Australian residential structures. Results from this study are shown as red dots with identifying house numbers. Note that House 5 was a poorly braced high-set house compared to Houses 1, 2, and 3 giving it greater vulnerability. The blue dot labelled 'H' is the data point for the house on Hooke Street that was not floated.
